Determining the causes of the solenoid coils incorrect winding

Abstract: Accurate placement of the wire is required during solenoid coils winding. Because many incorrectly wound coil were produced on the used winding machine, the analysis of this situation causes were to be realized. The winding machine precision measurement and simulation of the wire winding to the coil composite skeleton are described in this article.

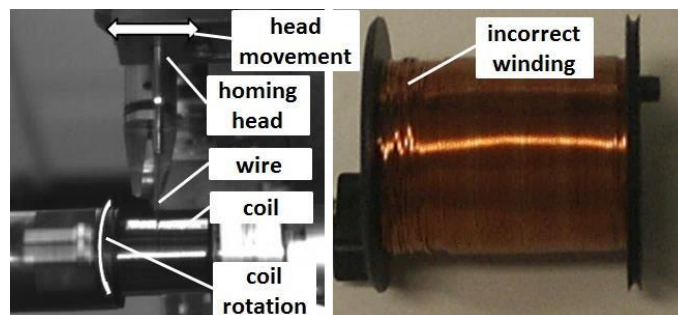
Accurate placement of the wire is required during solenoid coils winding. It means that the wire turns must be placed side by side, the wires must not be crossed (see Fig. 1). Because used winding machine produced a lot of incorrectly wound coil, the analysis of possible causes was realized. The homing head and coil rotation poor synchronization was the first possible cause of the incorrect winding so the machine precision measurement was first step which was carried. Because the bad winding cause was not revealed by this measurement, the winding process FEM modeling was done in the next step.

Fig. 1: The winding machine principle (left) and incorrectly wound coil (right).

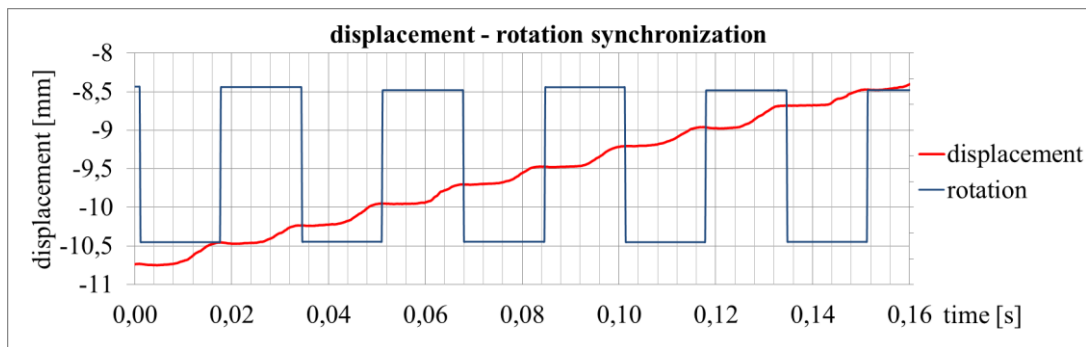
Fig. 3: The head displacement and the coil rotation synchronization.

Each coil turn is represented by one pulse from the digital sensor and regular displacement increment is evident in every step. So, the synchronization of the head displacement with the coil rotation is perfect too. It means that the winding problems are not caused by the imprecise machine function. Nevertheless some coils were incorrect wound during these measurements.

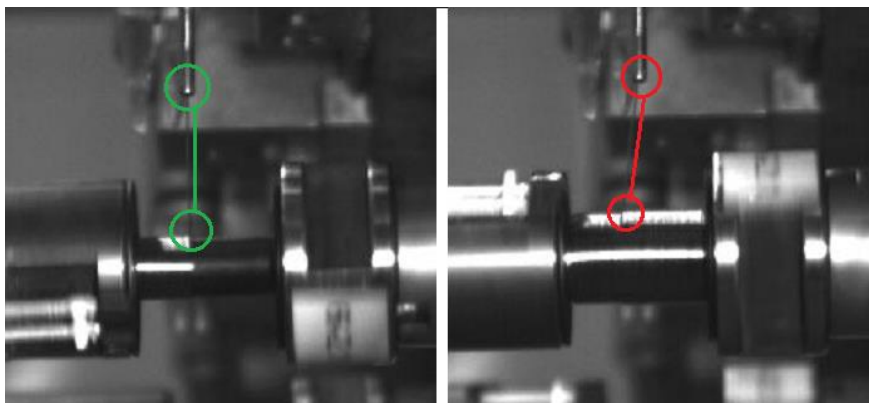
The analysis of video records showed that winding errors always start close to the coil sidewalls and it indicated a potential problem with their stiffness. The sidewall is probably pushed by the wire winding force and the wire is wound into incurred gap instead of the next layer. The homing head position and the coil winding position are out of sync, the wire is not guided perpendicular to the coil axis (see Fig.4) and incorrect winding is caused by them.

Fig. 4: The head and the coil winding good (left) and bad (right) position.

The carried measurement confirmed that the winding machine works correctly, all monitored signals are into prescribed accuracy limits. Video records showed problems with the coil sidewalls, their distance increases due to the winding wire tension force. It was confirmed by FEM model, too. The coil body will have to be redesigned (sidewalls thickness increased) for the winding problem solving [3].

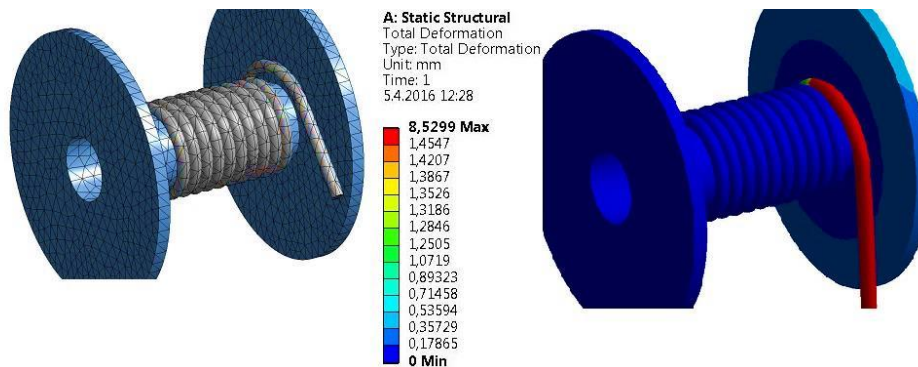
The Ansys software was used for the winding process modeling [2]. Winding wire was loaded by axial force 20N. Between the wires was set frictional contact. The coefficient of friction was 0,1. Also between the wire and the composite bobbin was set frictional connections 0,1. The wire winding force is forced between the coils and the whole spool (see Fig 3), where the right part of the figure is a mesh and left part - deformation results for the wrap angle of the wire 40°. Maximum deformation is in bend of wire, but through the contact between previous coil and bobbin sidewall makes the deformation of sidewall.

Fig. 3: The winding process FEM modeling net and deformation results.

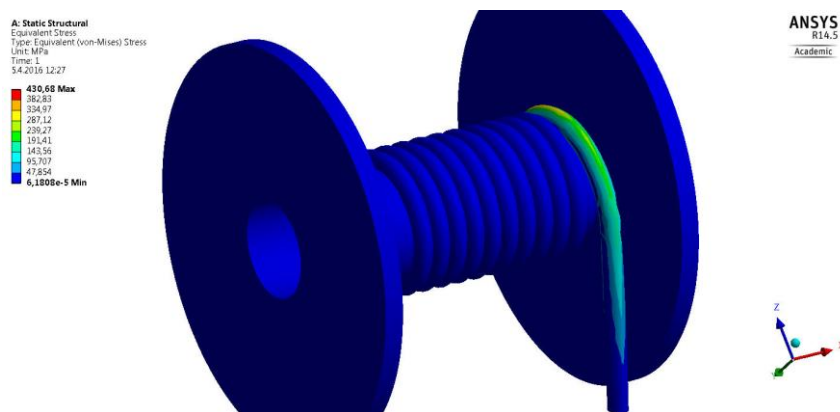
This deformation makes the stress in wire, also in sidewall of bobbin. On the Fig. 4 is maximal reduced stress in the wire. The wire is during winding bended and tensioned. But this stress is mode bigger than in the side of bobbin. Stiffness of bobbin is too small and sidewall is easy bended. Stress in beginner of winding is given by small diameter of coil on core of bobbin and often make permanent deformation of wire. This is only static calculations; in real the speed has affects on value of stress.

Fig. 4: The winding process FEM calculation of stress HMH.

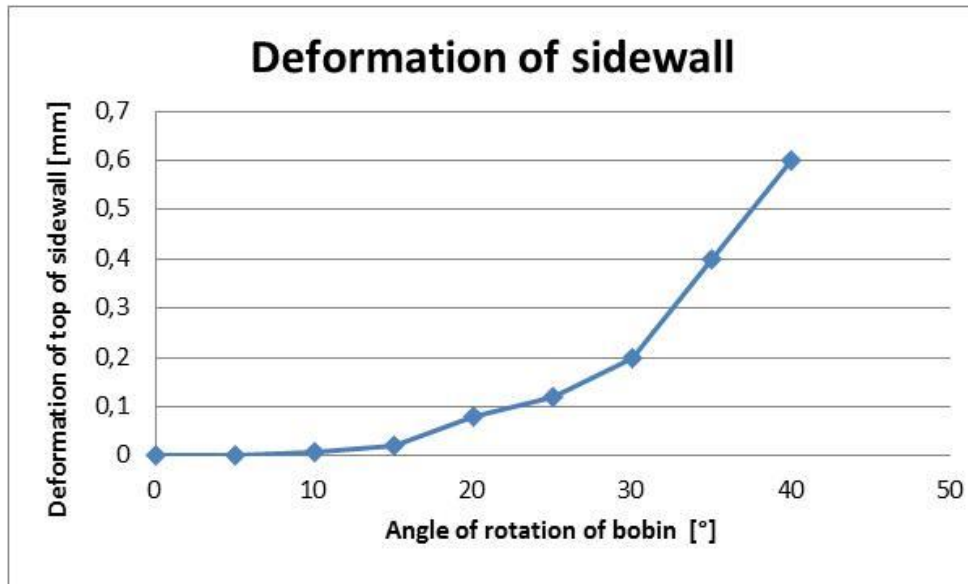
The following graph (Fig. 5) shows the results of successive static calculations. Calculations were made from the first contact with the face of the coil wire. It was also made of the wire winding 5 degrees. The calculation was deducted deformation forehead and plotted for each angle in the graph.

Fig. 5: Deformation of sidewall depending on contact angle.

This effect may or may not always occur. It depends on the position of the rack, on the contact points and the state of the shape geometry of the wire. In practice, the error usually occurred in the fifth layer of coils. The highest cost layer number can cause the greater the probability of errors.
