Influence of Distribution of Finger Joints and Timber Flaws on the Damage Evolution of Laminated Glued Timber Beams

MELZEROVÁ Lenka^{1, a}, ŠEJNOHA Michal^{1, b}

¹ CTU in Prague, Faculty of Civil Engineering, Department of Mechanics, Thákurova 7, 16629, Prague 6, Czech Republic

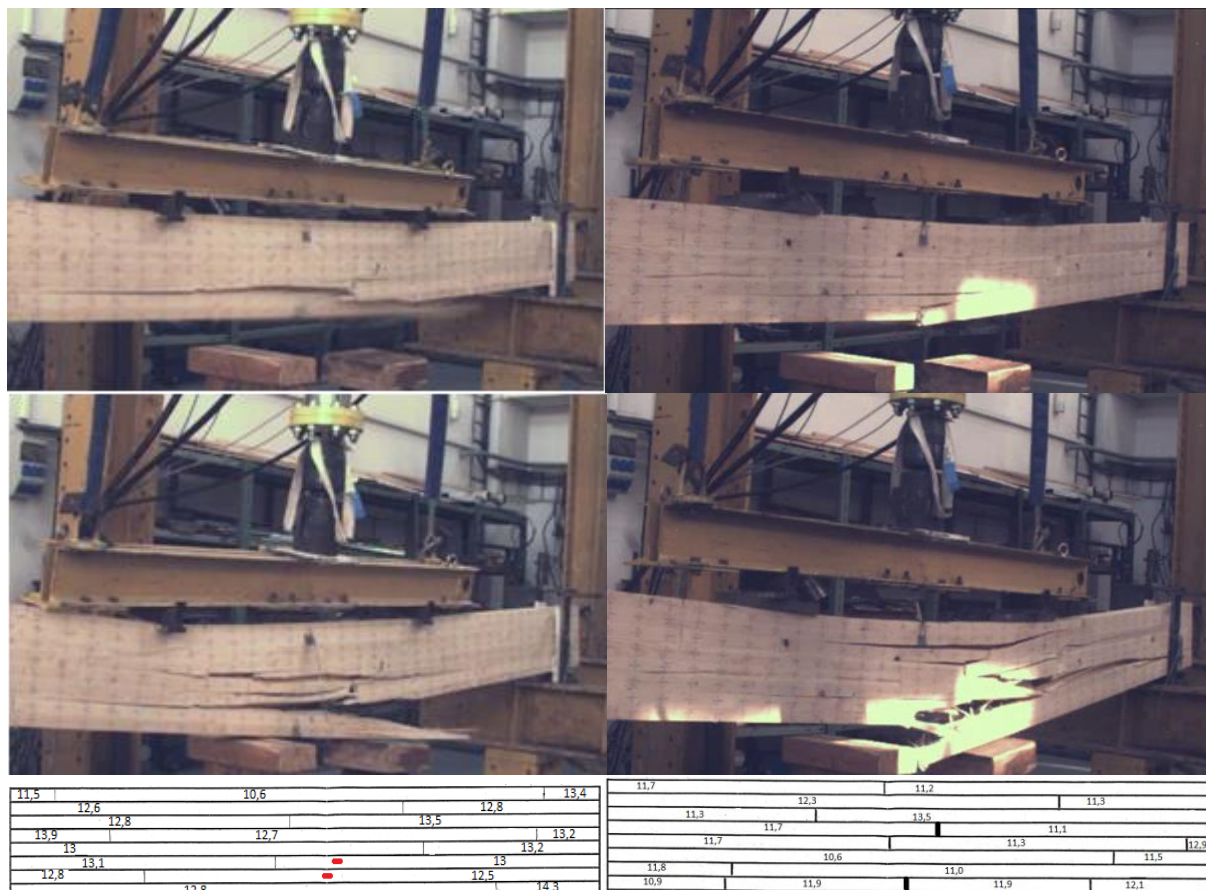
Beam1. The beam No. 1 experienced loading out of the original loading plane just prior to the final collapse. This might explain its relatively low bearing capacity equal to 68kN only. The onset of failure can be attributed to a pair of large knots in the middle part of the beam having the distance of 35mm only and spreading the entire thickness of the second and third bottom plies, respectively, see Fig. 2.

Beam 2. The beam No. 2 experienced the first failure in the finger joint which happened to be located exactly in the center of the bottom ply. The failure then propagated to the right up to the second bottom ply. Next crack opened in the third bottom ply, which was found to have the smallest average stiffness over the entire length, see Fig. 2. The next failure appeared in a poor-quality joint in the fifth ply from the bottom located 25cm to the right from the first failed joint. This was followed by the total collapse connecting all preceding cracks. This beam reached the collapse load equal to 88kN. As seen from Fig.2 it contained five finger joints located in the central part of the beam with one not suitably placed in the beam center. The partial design recommendation thus suggest to avoid application of poor-quality joints, to divide the most loaded bottom ply into the least number of laminations and to distribute all joints evenly throughout the beam.

Figure 2: Final collapse of the first beam at the load of 68kN and final collapse of the 2nd beam at the load of 88kN

These partial results suggest the following rather intuitive recommendations. First, large knots spreading the whole lamination thickness should be removed. If that is not possible, we should avoid grouping of knots. One should also pay attention to the location of finger joints and if possible to avoid their grouping at least in the most stressed section of the beam as well.

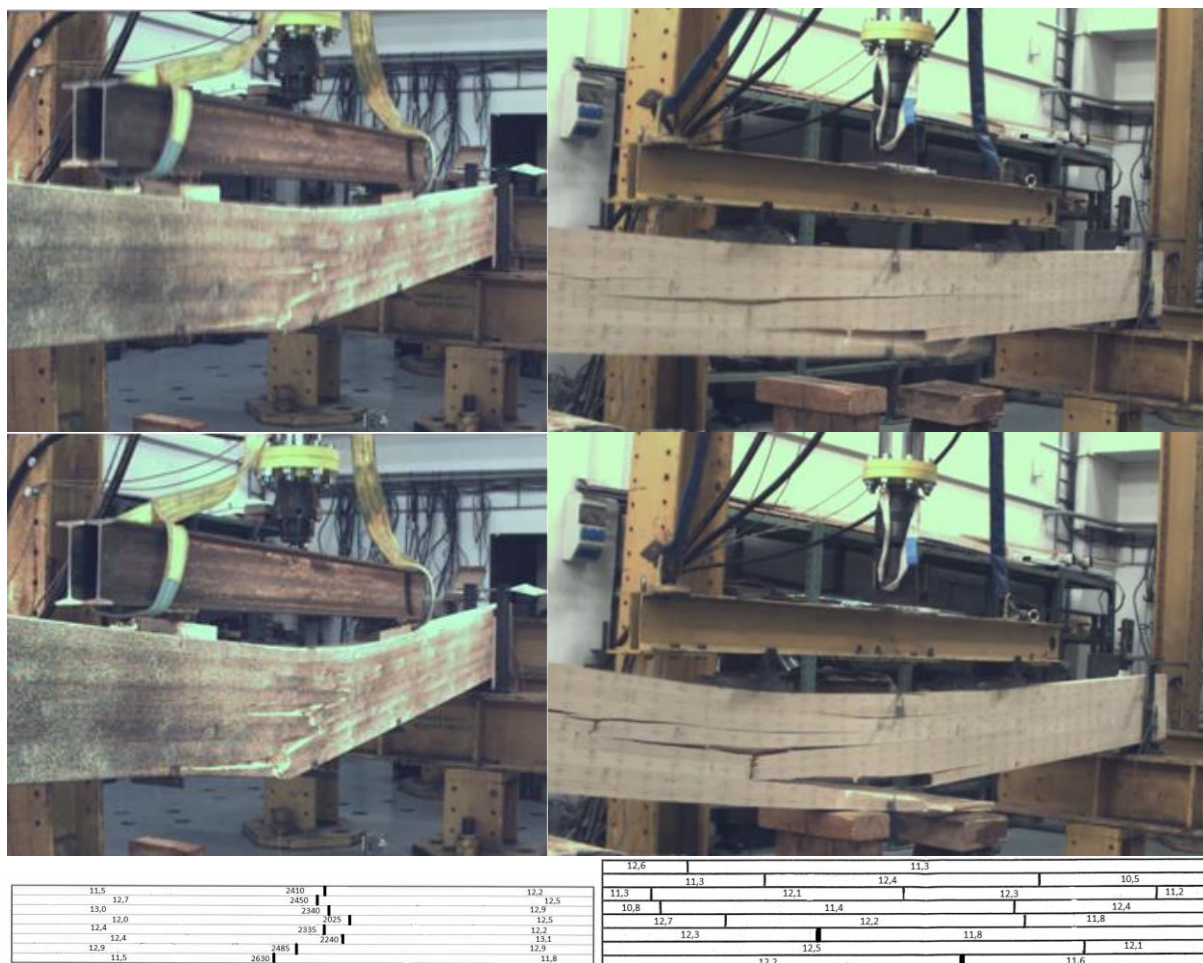
Beam 3. This beam achieved the same bearing capacity as the previous one. Even here the distribution of finger joints is completely unsuitable. Each ply contains one finger joints found within a 60cm wide band around the beam central part. Five of them, all located in first five bottom plies, were damaged upon the final failure of the beam. The failure mechanism is therefore rather predictable.

As shown in Fig. 3, the beam broke from bottom up due to crack propagation from one joint to the other. In this case, the distribution of large knots and an average stiffness of individual laminations had no effect on the beam failure, even though the two laminations with the smallest stiffness were placed in the bottom ply.

Beam 4. This beam reached a bit higher load bearing capacity equal to 96kN. The failure mechanism was, however, similar to the previous one. Herein, the first crack initiated from the damaged finger joint in the bottom ply and propagated towards the finger joint in the third bottom ply. Most probably, this region contained a hidden defect leading to fracture of the fourth ply in the same location. This indicates the need for identification and removal of such defects prior to gluing. The crack then propagated within this ply in the longitudinal direction. Yet before the final collapse another crack initiated in the fifth ply in the section having a significantly smaller stiffness of about 11.4GPa in comparison to the surrounding, see Fig. 3. Similarly to the previous cases, a finger joint located in the center of the beam caused the final failure. This further supports the need for not having joints in the most stressed regions. Apart from knots and finger joints, we might also want to concentrate on at least approximate knowledge of elastic moduli in individual laminations. These should be examined prior to manufacturing to avoid placing laminations of a large stiffness difference next to each other. This is certainly achievable for machine-wise classification of wood.

Figure 3: Gradual evolution of cracks. Location of finger joints measured in mm from the right and final collapse of the first beam at the load of 96kN.

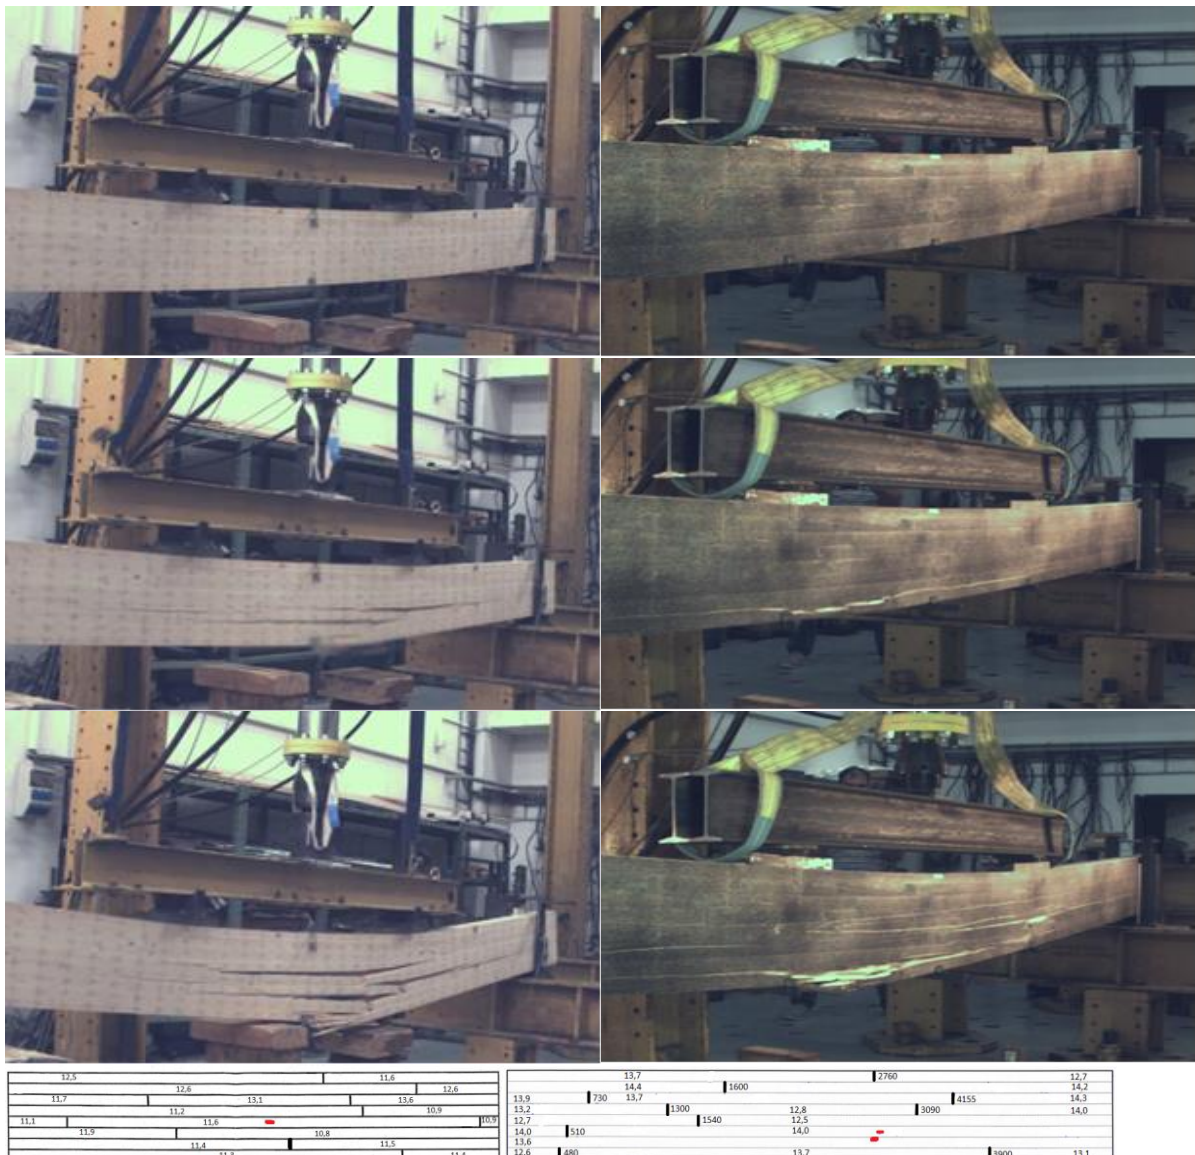
Beam 5. A totally different failure mechanism has been observed for the last two tested beams having a considerably higher load bearing capacity. This beam, the last before one in terms of bearing capacity, collapsed at the load of 128kN, which is more than 30% higher load than encountered for the previously discussed beams. On the other hand, the actual progress of damage resembled almost a brittle failure. The first two photographs in Fig. 4 were taken 1s apart. Only one finger joint, highlighted also in Fig.4, failed in this case. Again it was damaged not until propagation of longitudinal cracks. The sequence of photographs in Fig. 4 further indicates that no finger joint contributed to the beam failure as three longitudinal cracks developed in the middle most loaded section of the beam. The first crack initiated in the third bottom ply having the lowest stiffness equal to 10.8GPa. This was also the lowest value of the Young modulus among all tested laminations. The next crack appeared one ply above with the average value of the Young modulus equal to 11.6GPa. Occasionally, the crack propagation was terminated at the finger joint. These joints, however, were always found out of the most loaded central part of the beam. Fracture of the bottom ply approximately in the middle of the beam took place at the final stage of the total collapse. Reading the damage pattern was simplified through a regular grid of points, where indentation measurements of Young's modulus took place.

Beam 6. The last beam with the highest load bearing capacity failed at the load level of 148kN. The failure mechanism was similar to the beam No. 5 so that the beam failed again due to the massive evolution of longitudinal cracks as seen in Fig. 4. In this case the first crack initiated in the bottom ply below the left force and propagated through the

corresponding lamination to the right up to the point of force application. The first failure was followed by the evolution and propagation of cracks in the second and third bottom plies starting in the vicinity of two large knots below the right force. The whole fracturing process is documented via a series of photographs in Fig. 4. Checking the average values of Young's modulus we notice a smaller value of longitudinal modulus in the first two bottom plies in comparison to the third ply. The lower value of the elastic modulus suggests also a lower wood density and consequently a lower strength. Nevertheless, these moduli are still of about 1 to 2 GPa higher when compared to the beam No. 5. This explains, together with a better redistribution of finger joints in the most stressed section, its larger load bearing capacity. The two finger joints in the bottom ply played no role as they were located out of the most stresses section. By coincidence the second bottom ply was compact made of one lamination and the third bottom ply had a finger joint close to the support. On the contrary, there was a finger joint in the center of the top ply. It thus can be expected that flipping the beam upside down would result in a much lower load bearing capacity. So apart from grouped large knots in the most stressed section the position of the beam should be correctly selected.

Figure 4: Beam with load bearing capacity equal to 128kN with identified location of a large knot and damaged finger joint and beam with load bearing capacity equal to 148kN and the location of pair of knots.
