Reliability Assessment of Saint Joseph Church in Prague

¹Klokner Institute, Czech Technical University in Prague, Czech Republic

The Klokner Institute was asked for the reliability assessment of the St. Joseph Church in Prague which is listed as a Czech national cultural heritage monument. The church was built within 1636-1653 as a part of the Capuchin monastery. The monastery was later rebuilt to neo-Romanesque barracks and recently transformed into a shopping centre Palladium. At present the church is thus situated closely to the shopping centre, hidden behind the wall which separates the church from the Republic Square and which creates a small courtyard decorated by two Baroque statues (Fig. 1). The interior of the church is quite simple. Lateral altars are decorated by two large paintings by the famous Czech painter Karel Skreta. The vertical walls of the church are made from stone masonry and ceilings include cylindrical vaults. The church is partly provided with cellars.

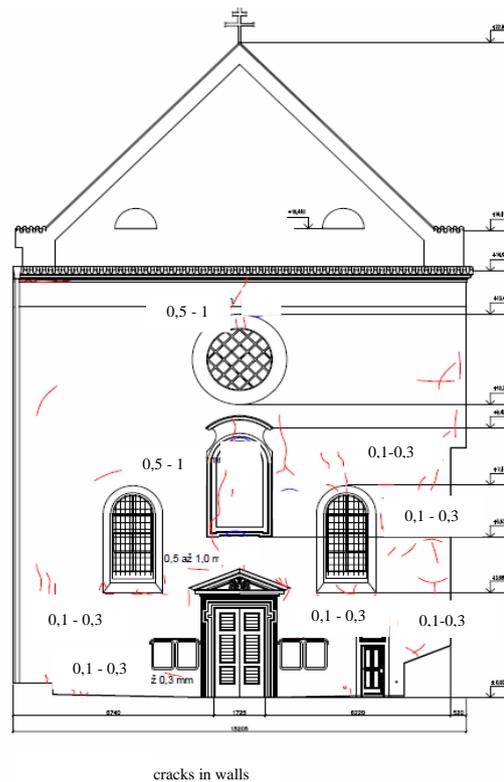
Fig. 3. Cracks in the front part of the church (in mm).

New survey of damages was undertaken (Fig. 3) and compared with the results of the previous one. Inspection revealed that several new damages appeared in the main church nave. In the wall neighbouring to the Palladium shopping centre, several new cracks of the width from 0.3 to 4 mm are visible. Main cracks extend to the arches and also to the ceilings, damaging the paintings. Cracks up to 4 mm in the masonry and considerable floor deformations appeared in the main nave.

The largest cracks of width of 5 mm were found in the east side of the church. In the west wall, the cracks in tops of the vaults width from 0.5 to 2 mm appeared. Considerable cracks exist between the west wall and the vault of the main nave. The cracks are present in most rooms of the church. Several wider cracks exist in the gable parts of the church. It might be assumed that some of them could be present before the construction of the new underground.

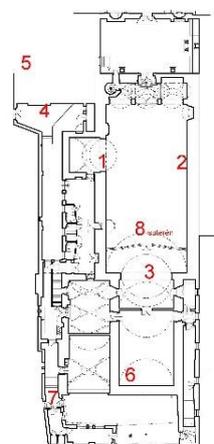
To estimate the influence of surrounding environment on the church, the traffic was monitored by a one channel vibrometer in May 2014. Passages of trams, buses, impacts of human activities and some other sources of vibrations were measured and evaluated as is reported in Table 1 (indicating maxima) accompanied by a floor layout with locations of the monitored points.

The measured maxima of the traffic effects are about two orders lower in comparison with the limiting values which might potentially have some influence on the cracks formation. It is thus concluded that the traffic in the vicinity of the St. Joseph church has insignificant influence on cracking of masonry structures.

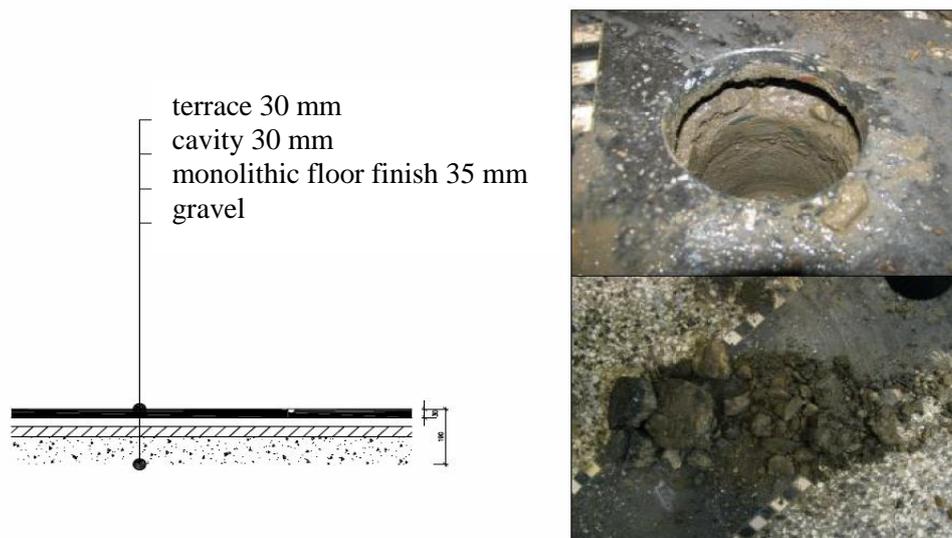
One destructive test was made in the location of the floor deformation. The aim was to investigate the composition of the floor layers and reveal the cause of deformation. It was suspected that the floor might be influenced by the pressure of underground water. The composition of floor is illustrated in Fig. 4 where the cavity of the thickness from 0.03 m to 0.15 m under the layer of historic terrace.

Fig. 4. Test pit in the location of the deformation of the floor.

No underground water nor injected mortar used for the soil strengthening were not detected by the test. It appears that the deformation of floor is caused by the horizontal movements of the neighbouring shopping centre.

A destructive test of the deformed floor revealed a hollow without underground water or injection mortar due to former geotechnical protective works. It might be concluded that there might be an influence of local lateral pressures of structures, potentially in combination with uneven settlements of the foundations having impact on the deformation of floor in the main church nave.
