## Determination of the Cause of Failure Based on Fracture Marks on Parts of a Complicated Transmission Mechanism

**Abstract.** Device failure or a failure of its part can be caused by different factors. These include for example deficiency of assembly, operation conditions, or their closely related fatigue failure. In this paper, we deal with analyses of pivots fatigue failure and causes of the occurrence of this kind of failure in the transmission mechanism of a mixing device.

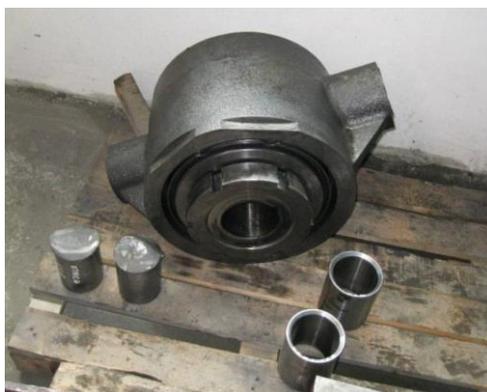
The breakdown appeared on the gearbox of a mixing and dosing device whose output shaft, along with rotational movement, also performs a translational movement which is secured by means of a rather complex gearbox made up of a conical differential, excentres, a connecting rod and a so-called crosser. The damage, in the form of fatigue failure, was apparent in the “crosser” by the breaking off of both pins which are located on the sides (fig. 1).

Fig. 1 Damaged crosser with broken pins and caps

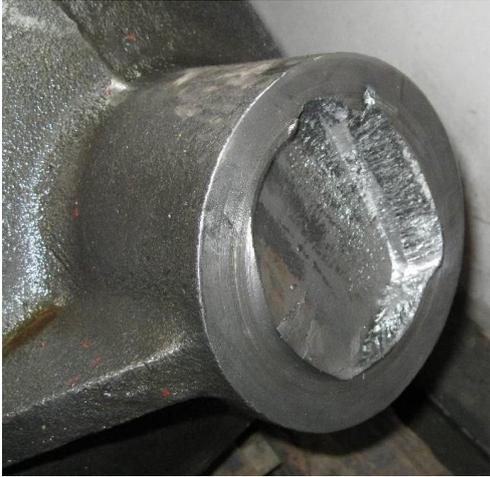
- On the crosser's left pin were clear marks of damage in the form of a fatigue fracture (fig. 2). From the figure it is clear that the fracture came from the side of the pin's rib stiffener and its initiation was in the place of the rounded transition from the crosser body to the pin (pin diameter 107 mm);

Fig. 2 Fracture of the left crosser pin

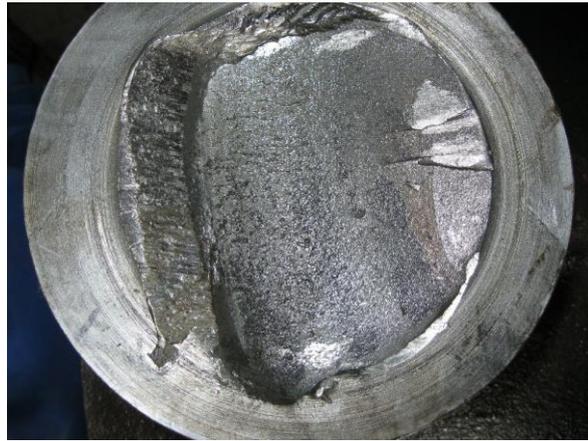
- the fracture area had conchoidal marks from the expansion of the fracture concentrated at the initiation point. The relatively rough area of the fatigue part of the fracture witnesses to intensive widening of the crack, leading to a sudden fracture. The opposite side of the fracture area showed characteristics of shearing (fig. 3);

Fig. 3 Structure of the fracture area of the left crosser pin

- from the relation of the size of the area of the fatigue part of the fracture and of the sudden fracture it can be concluded that the amplitude of transition burdening exceeded the mean tension value. The direction of the expansion of the fatigue part and the position of the breakage, as well as the character of the surface of the fracture, suggest strain from unsymmetrical bending in the plane of the pin axis and in the movement of the crosser. The unsymmetrical bending stress results from the differentiated pin pressure as the crosser moved forwards – supplying the material and return movement;

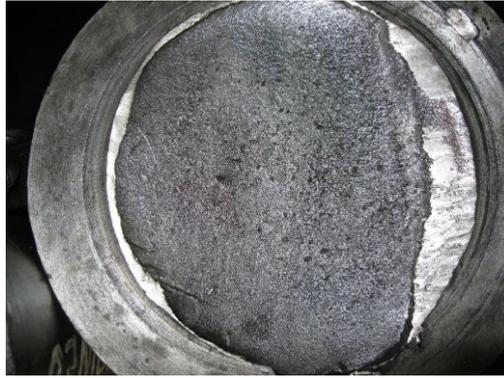
- significant marks of expansion of the fatigue fracture were not found in the fracture area of the right pin (fig. 4). The surface remained rough, with a small fracture area. The fracture here took place more quickly than on the left pin. The initiation of the fracture, the expansion direction, the fracture position and also the character of burdening were similar as in the case of the left pin.

From the inspection and analysis of the fractures of the pins on the individual sides of the crosser, there resulted the conclusion that the occurrence of the fatigue cracks were the effect of probably unbalanced burdening and to a large degree oversizing when placing the caps on the individual pins.

Fig. 4 Structure of the fracture area of the right crosser pin

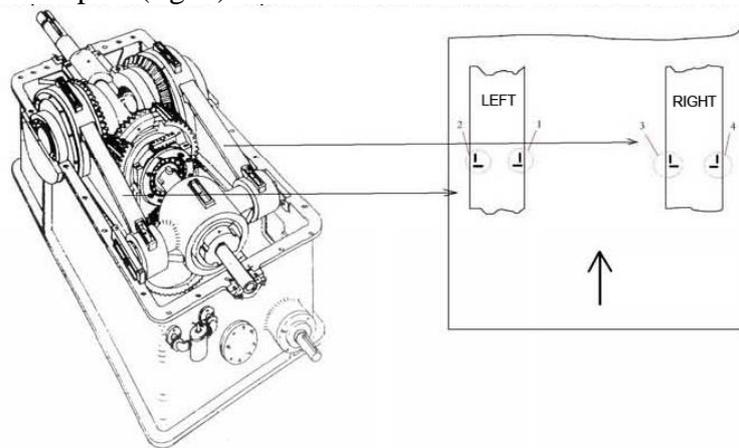
Fig. 6 Location of strain gauges on connecting rods

wherein strain-gauge sensors were placed on the left and right sides of the upper flanges in the proximity of the crosser pins (fig. 6).

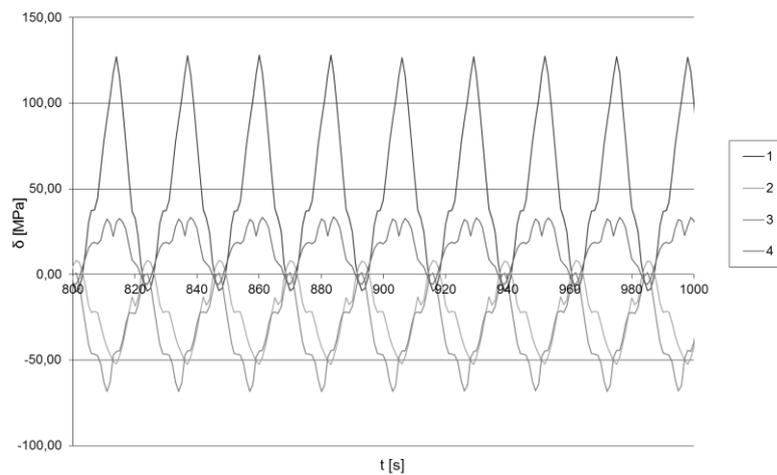
From the measured values it was clearly demonstrable that the assumption of inaccurate matching of the two excentres was confirmed. From the measured record (fig. 7) it was clear that in the movements of the mixing worm to the stroke (movement of the material) there was manifested on the left interior side about twice as much burdening as on the right exterior side, which clearly caused the bending stress on the crosser pins.

Fig. 7 Detail from the measured record

1. + 136,9 MPa
2. - 57,1 MPa
3. - 71,4 MPa
4. + 37,1 MPa
