Experimental Verification of Stress State in Selected Steel Load-Bearing Elements of Silo

Keywords: Silo, Measurement, Tensometry, Safe Operation

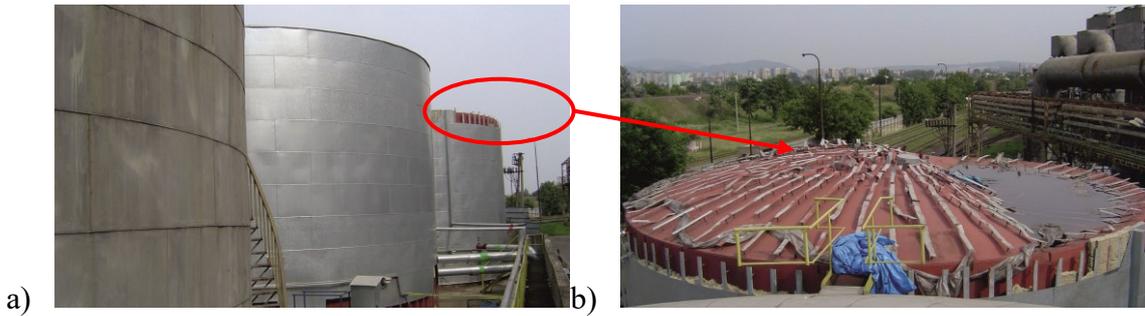
Fig. 1: a) View of storage tanks, b) collapsed roof of the storage tank

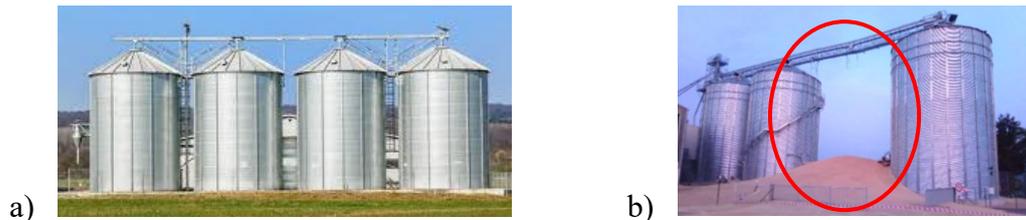
Fig. 2: Steel silos a) without failure, b) collapse of a silo for the storage of approximately 120 t of wheat

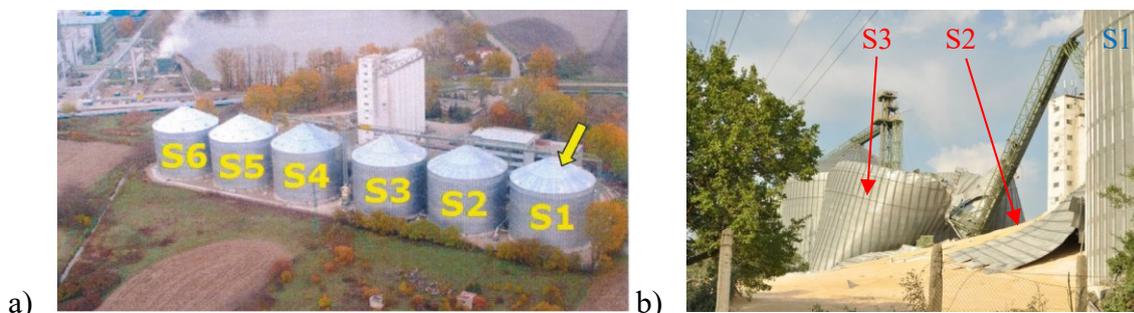
The paper presents the procedure of experimental measurement on steel supporting structure of the silo S1 (Fig. 3a) located near the collapsed silo S2 (Fig. 3b). As presented in Fig. 3b, the collapse of silo S2 also caused the breakdown of the adjacent silo S3. Although the structure of silo S1 did not show any signs of damage at first sight, the operator decided to assess safety and reliability of its future operation through the outputs of the analysis of experimental measurements. The circumferential walls of the silo are made of steel profiled sheets, the corrugated profiles of which run in the horizontal direction. The structure is reinforced around the perimeter with vertical stiffening profiles. The stiffeners are evenly distributed around the circumference of the silo along the entire height of the cylindrical part.

Fig. 3: View of the analysed silo S1, a) before breakdown, b) after breakdown

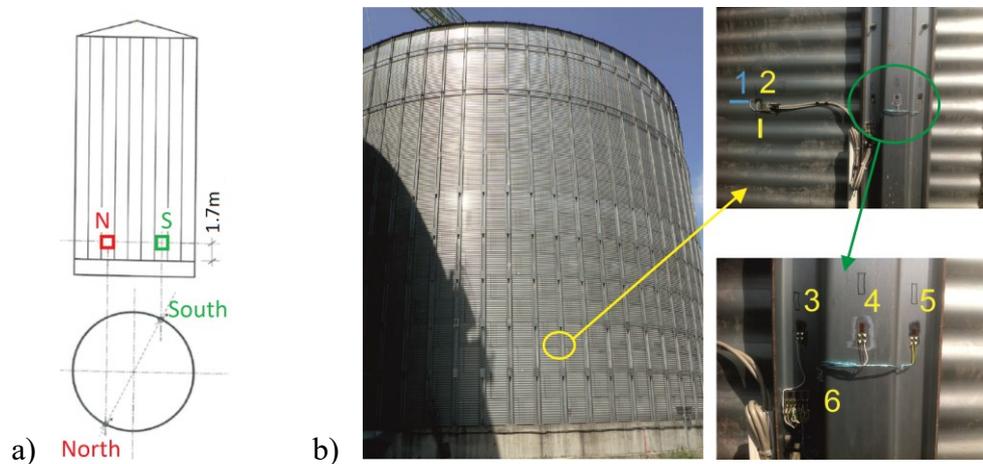
Fig. 4: a) Location diagram of strain gauges, b) orientation of grids

Fig. 4b shows a detailed view of the applied strain gauges on a corrugated sheet (areas 1 and 2) and on a stand (areas 3 to 5). In addition to the mentioned strain gauges, a temperature sensor type FNA611L0100 was used in the vicinity of strain gauges.

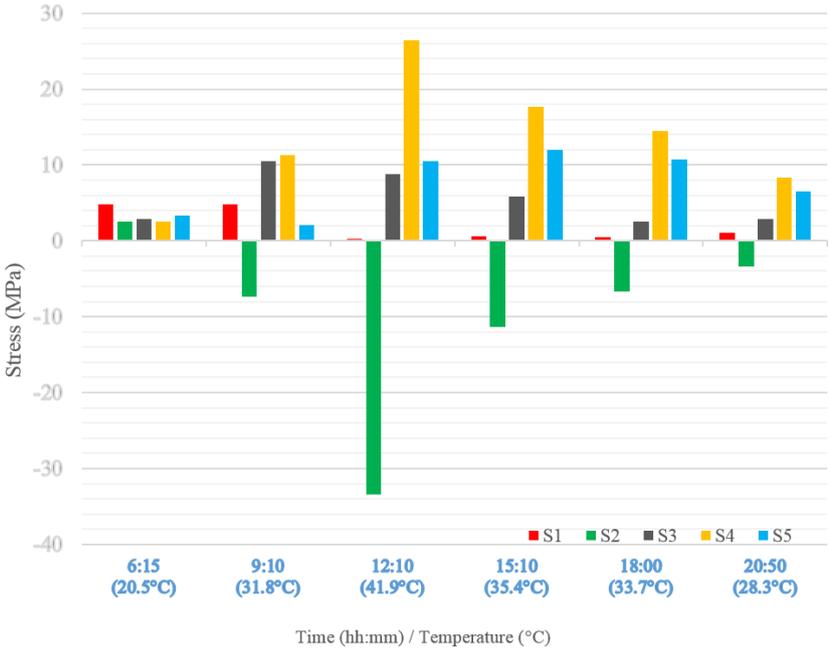
An overview of the values of recalculated stresses is given in Graph 1 and 2. The given values imply that during that day both tensile and compressive stresses were recorded. The maximum values were measured on the south side at noon, as expected.

Graph 1: Stress values depending on the influence of ambient temperature within one day – south side

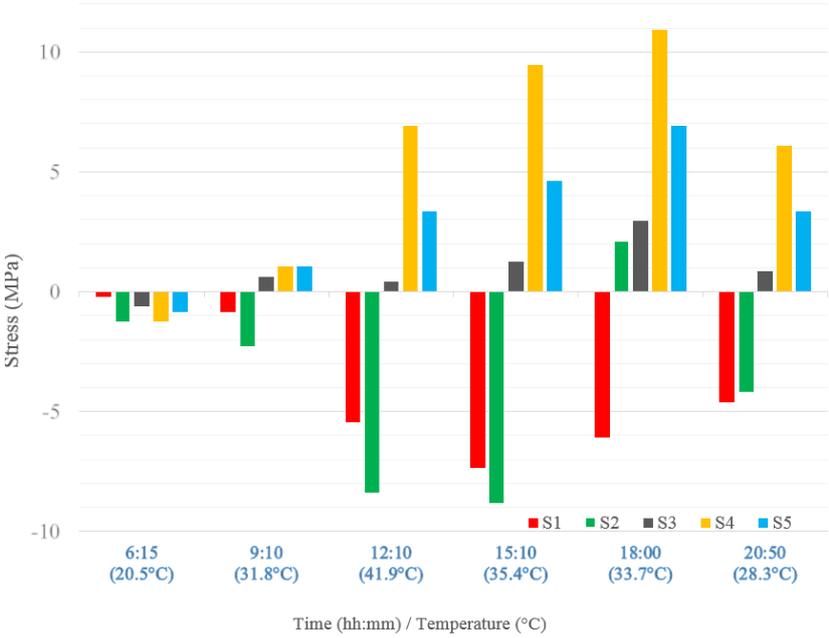
Graph 2: Stress values depending on the influence of ambient temperature during one day – north side
