František TREBUŇA *, František ŠIMČÁK **, Jozef BOCKO ***, Vladislav BERINŠTET ****

ASSESSMENT OF VENTILATOR FAILURE ON EXHAUSTING OF CONVERTER

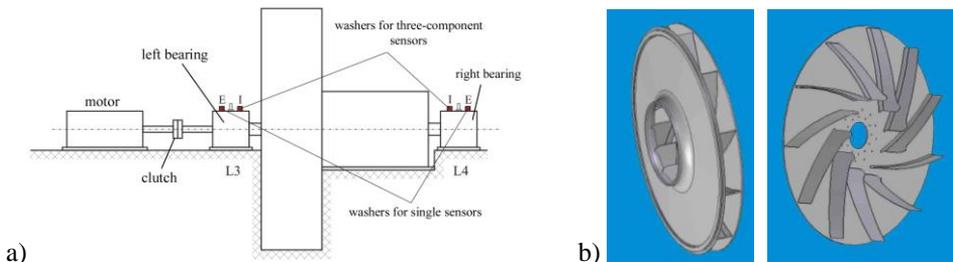
Crashed ventilator was used for exhausting of converter gas during operation of converter. Radial ventilator in question has rotor diameter approximately 3 m. It lies in two bearings and it is powered through the clutch by electromotor (Fig. 1a).

Fig. 1 Radial ventilator a) whole view, b) rotor with details of blades.

In Fig. 1b is given model of rotor that was used for computation by the finite element method. Rotor with outer diameter 2923 mm is welded and consists of covering sheet (thickness 12 mm), supporting sheet (thickness 20 mm) which is fastened to the flange of ventilator's shaft by 24 bolts and eleven blades made of steel sheets of thickness 12 mm and 20 mm (Fig. 1b). After several months of operation with 600 to 1400 rpm was the rotor damaged and consequently was damaged also whole

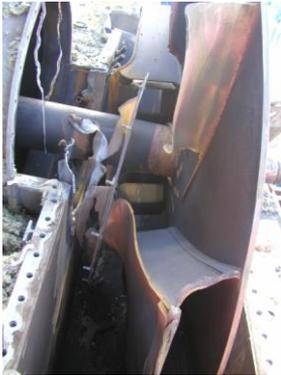
fan. In Fig.2 is view to crashed rotor and deformed covering sheet of ventilator case. In Fig.3 is shown right bearing house of ventilator before and after crash. On the base of visual analysis of broken surfaces was found out that the first damaged element of ventilator was its rotor. This fact was confirmed by additional revision of rotor in the second parallel ventilator of the same type that is used for the same purpose. Penetration test of non-damaged rotor has confirmed presence of crack in supporting sheet of rotor. That is the reason why were the causes of crash searched in the properties of rotor. In the paper are given the results of numerical and experimental analysis with the aim to determine the reasons of failure of individual parts of ventilator.

Fig. 2 Damaged rotor and covering steel sheet

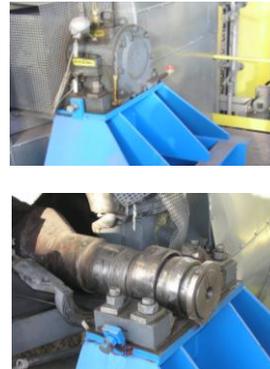
Fig. 3 Right bearing house of ventilator before and after damage

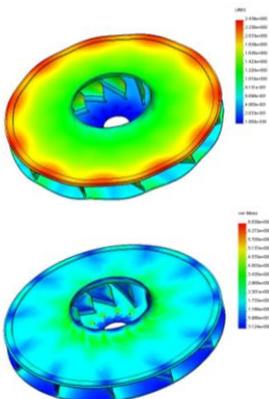
The finite element method was used for determination of stresses in the rotor of the ventilator as well as for computation of its eigenshapes and eigenfrequencies. Model of rotor for the stress analysis is shown in Fig. 1b. In Fig. 4 are given deformations and equivalent stresses in rotor for frequency 1400 rpm. The shaft was modelled for computation of eigenshapes and eigenfrequencies of rotor. In Fig. 5 is the first eigenshape of vibration. Corresponding eigenfrequency is $f = 18,759$ Hz for the rotor without rotation and $f = 31,817$ Hz for rotation frequency 1400 rpm. Eigenfrequency that corresponds to the third eigenshape was $f = 31,376$ Hz without rotation of rotor and $f = 52,697$ Hz for rotation frequency 1400 rpm. The second eigenshape (and also the second eigenfrequency) were in essence the same as the first eigenshape (ortogonality is preserved).

Fig. 4 Strains and equivalent stresses in rotor

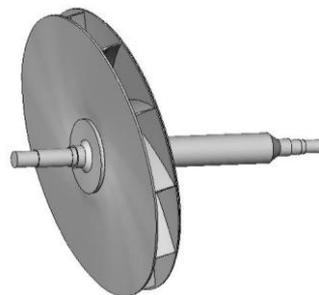
Fig. 5 The first eigenshape of rotor with shaft

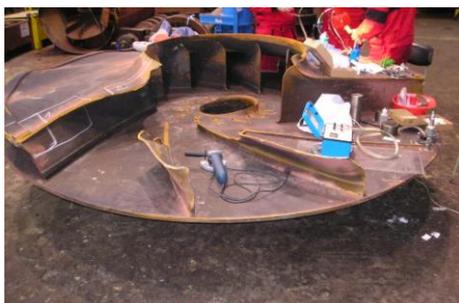
Because the crack in ventilator was located in welds or in intimate distance from the welds on the rotor (Fig. 6) there was accomplished measurement of residual stresses around welded joints. These stresses have very harmful effect because they contribute to material fatigue and they decrease lifespan of structure.

Fig. 6 Damaged rotor prepared for measurement of residual stresses

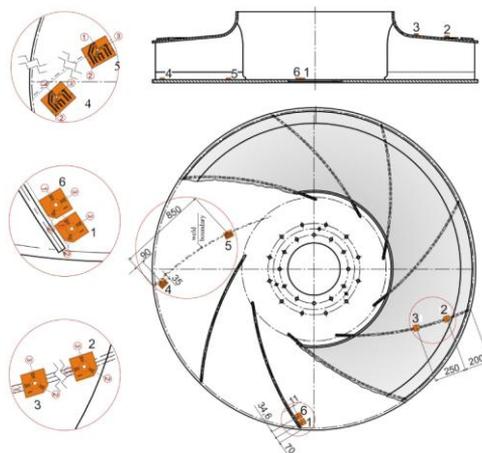
Fig. 7 Schema of strain gages locations and orientations

The hole drilling method was used for determination of residual stresses. The drilling was accomplished by hole drilling equipment RS – 200. In locations 1,2,3 and 6 was for drilling near to strain gages RY –21 used cutter with diameter 3,2 mm and in locations 4,5 for the drilling near to strain gages CEA 062 UL the cutter with diameter 1,6 mm. Hole depth was 3,5 mm for locations 1,2,3 and 6 mm and 2,4 mm for locations 4 and 5. For the measurement of strains was used strain gage apparatus P3. The magnitudes of residual stresses were determined from measured strain by code ASTM E 837 – 01 [4] as well as by Integral method and Method of Power – Series [3]. In Table 2 are given values of residual stresses in individual locations according to code ASTM E 837-01 (it presumes regular stress distribution along the hole depth).

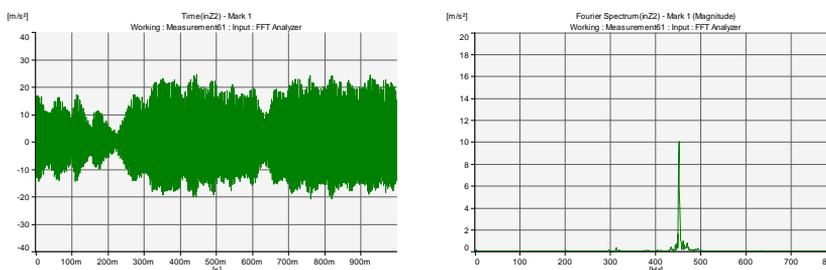
Fig. 8 Accelerations dependent on time and frequencies – Bearing L4, 1100 rpm

Experiences show that for broad band vibration is the best measure of dangerousness and harmfulness of vibration the effective value of vibration velocity v_{ef} because to the certain value of velocity corresponds certain value of energy. Code STN ISO 10816-1 categorizes ventilator in question to class III with the following band limits: A - $v_{ef} \leq 1,8 \text{ mms}^{-1}$ (new machines); B - $v_{ef} = 2,81 - 4,5 \text{ mms}^{-1}$ (common operation without time limit); C - $v_{ef} = 7,1 - 11,2 \text{ mms}^{-1}$ (not suitable for long-time operation – limited operation); D - $v_{ef} \geq 18 \text{ mms}^{-1}$ (not allowed values). Maximal acceleration and velocity amplitudes were, according to the measurements, for frequencies 450 – 460 Hz, maximal effective value of velocity reached $4,5 \text{ mms}^{-2}$ and this shift operation to boundary of band C that defines limited operation of ventilator.
