Experimental Modal Analysis of the Footbridge across Bečva River in Přerov

Tomáš Plachý¹ & Michal Polák²

Keywords: Damage; Flood; Footbridge; Experimental Modal Analysis

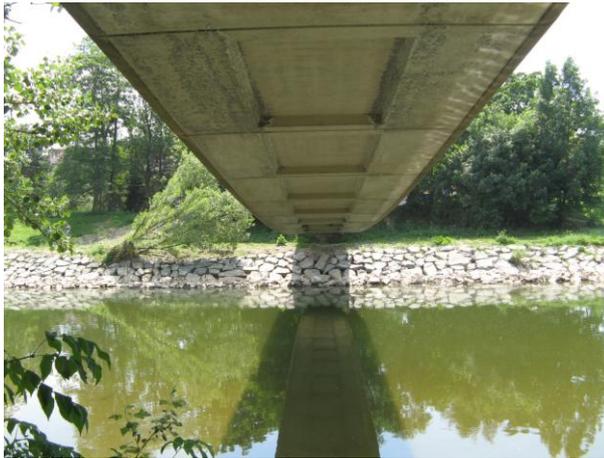
The substantial part of the footbridge deck was overflowed by extreme floods in July 1997 and May 2010. The significant increase of the permanent deflection of its main span was result of the second flood. The permanent deflection in the middle of its main span was increased about 1 m in comparison with the state before commissioning. This is why the footbridge was closed for all users immediately.

Fig. 1. The view on the lower face of the footbridge deck in the main span.

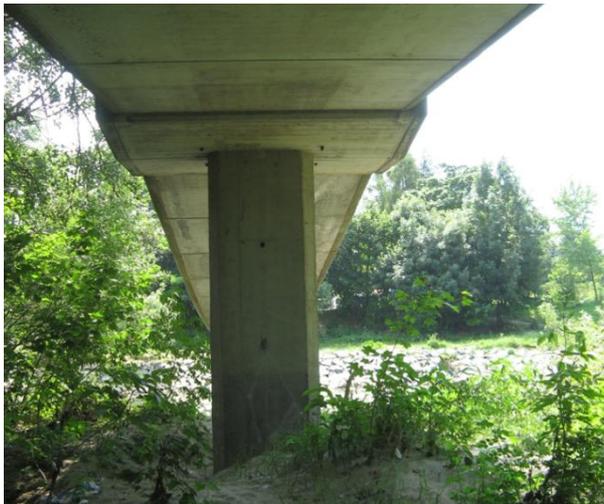
Fig. 2. The view on the intermediate support.

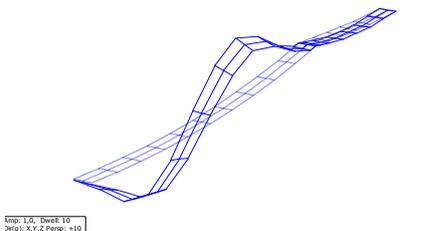
Fig. 3. The 1st measured natural mode shape of the footbridge – $f_{(1)} = 1.07$ Hz.

The results of the dynamic load test carried out on the footbridge in the June 2010 were compared with the results of the dynamic load test carried out on the bridge in 1983 before commissioning the footbridge. The significant change of the dynamic behaviour of the footbridge was found. Especially, the basic natural mode shape has totally changed its shape (see Fig. 3 and 4). The significant changes have occurred also for all other compared natural mode shapes.

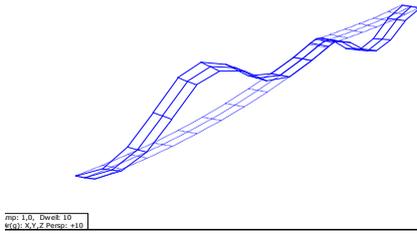
Fig. 5. The 2nd measured natural mode shape of the footbridge – $f_{(2)} = 1.50$ Hz.

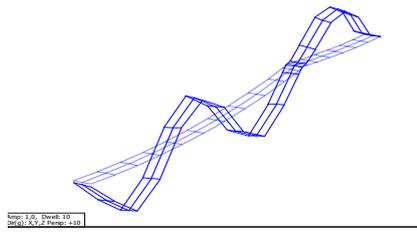
Fig. 6. The 3rd measured natural mode shape of the footbridge – $f_{(2)} = 1.85$ Hz.

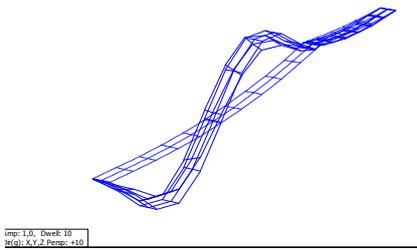
Fig. 7. The comparison of the 1st measured and computed natural mode shapes of the footbridge – $f_{(1)\text{exp}} = 1.07$ Hz.

The similarity of the measured and calculated natural mode shapes [2] was high (see Fig. 7 and 8). However, particular differences were found out (see Fig. 9 and 10). Based on the detailed comparison of the measured and calculated natural mode shapes, two areas were determined, where the behaviour of the real structure and the model was different. It was recommended to investigate these areas in more detail, because any damage or fault can be at these positions of the footbridge. One of these areas was near the pier. From the experiment it results that pier of the real footbridge is more flexible in the horizontal transversal direction than the theoretical model. This effect is visible from the Fig. 10 and from the comparison of the natural frequencies. Theoretical natural frequency of the horizontal natural mode is evidently higher than the corresponding measured one. During the following inspection of the footbridge, the crack was found in the area of the concrete hinge joint. After the static load test the footbridge was put into very limited operation.

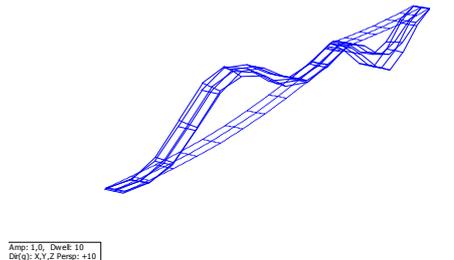
Fig. 8. The comparison of the 2nd measured and computed natural mode shapes of the footbridge – $f_{(2)\text{exp}} = 1.50$ Hz.

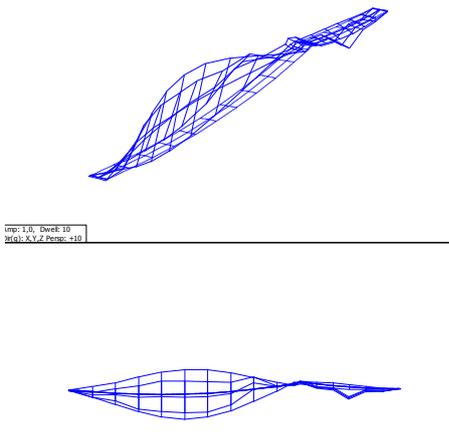
Fig. 9. The comparison of the 4th measured and computed natural mode shapes of the footbridge – $f_{(4)\text{exp}} = 2.16$ Hz.

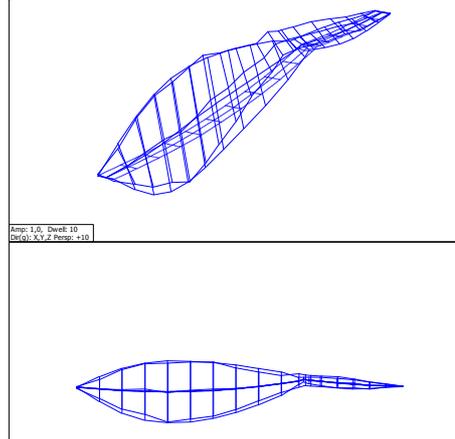
Fig. 10. The comparison of the 7th measured and computed natural mode shapes of the footbridge – $f_{(7)\text{exp}} = 3.49$ Hz.
