## Experimental verification of the mechanical properties of the material of the rotor shaft of the turbine damage

## Description of turbogenerator damage

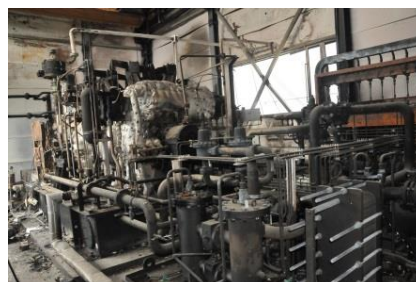
Cross-section of rotor in location of damage is loaded during operation of steam turbine by bending moment due to weight of rotor as well as by torque. The torque in the location of damage was caused by torsion moment of steam turbine. For the nominal rotations 8200 rpm, guaranteed power on generator (on terminals) 6 MW and efficiency 0.8, is the power of steam turbine after considering power lost on the rotation reductor equal cca to 7,5 MW. For nominal rotations 8200 rpm is the torque 8,74 kNm. Maximum stress due to torsion under nominal power in location of notch is 37,4 MPa. It results that such values of stress cannot lead to the failure state. State of equipment – steam turbogenerator after damage is given in Fig. 3.

Fig. 3 View to steam turbogenerator after failure.

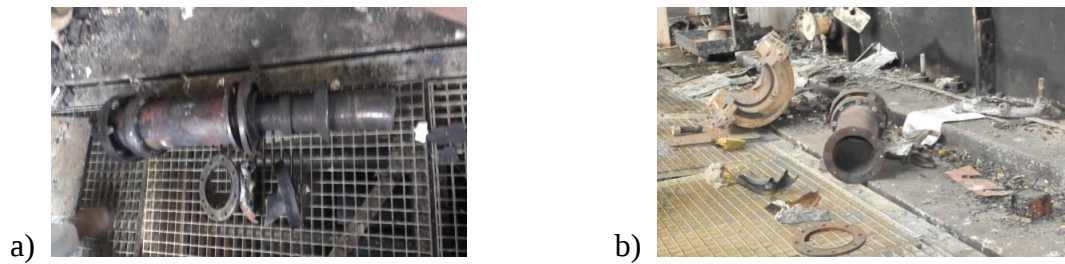
Fig. 4 a) Shaft connecting turbine rotor and reduction gear, b) view to the side of the shaft consists of a pipe.

The right side in Fig. 4a represents broken part of turbine rotor shaft from the location damaged by fatigue fracture, while the outer diameter of full shaft is 120 mm in the location of fracture. The left side shows a shaft that consists of a pipe (Fig. 4b) on the end of which is a flange of clutch. View to the second part of clutch (from the side of gear) under aluminium cover is shown in Fig. 5.

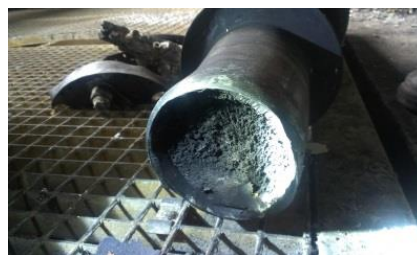
On the basis of photographs taken during inspection (Fig. 6) as well as views to damaged part of shaft with fractured surface (Fig. 7), plastic deformation near fracture location (Fig. 8), detail view to fracture surface (Fig. 9), but also shape of fracture surface can be stated that the failure of shaft is connected with fatigue process (concluded also by bright conchoidal fracture).

Fig. 6 View to broken part of turbine rotor shaft.

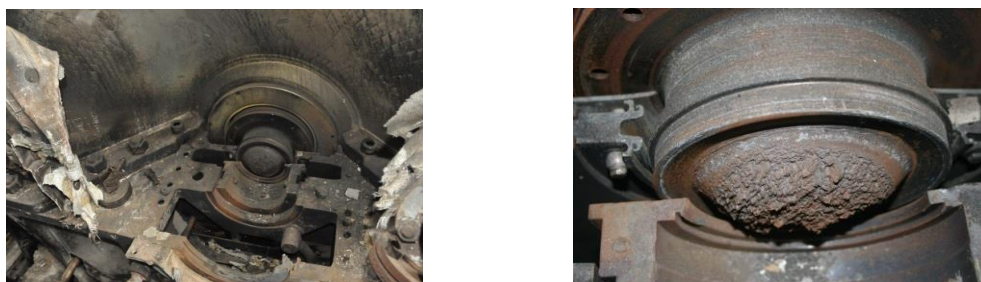
Fig. 7 View to fracture surface on the shaft on the side of turbine.

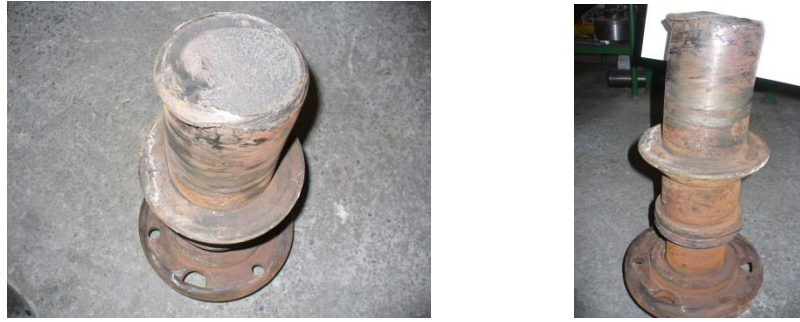
Fig. 8 Shaft with fracture surface.

Fig. 8 documents that during crack spreading the pressing of material occurred which were invoked by cyclic loading resulting from rotation of shaft and axial deformation of flange clutch. In Fig. 11a is shown the separated part of turbine rotor from which a material for tests was taken. The material for mechanical and metallographic tests, see Fig. 11a, was taken according to plan given in Fig. 11b.

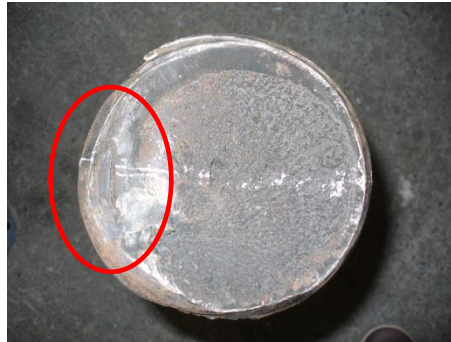
Fig. 9 Detail view to fracture surface – with marked area of macrocrack.

Creation of circular part of fractured surface concludes that it is resulting from combination of bending and torsion where the initial crack was caused not only by high level of equivalent stresses resulting from combination of bending and torsion, but also by stress concentrator due to defective structure of material resulting from smithing, Fig. 9. Such defective part together with sharp angle of relatively non-traditional shape (Fig. 10) localizes the area of first failure of turbine rotor shaft. This area was selected for further analysis of shaft material.

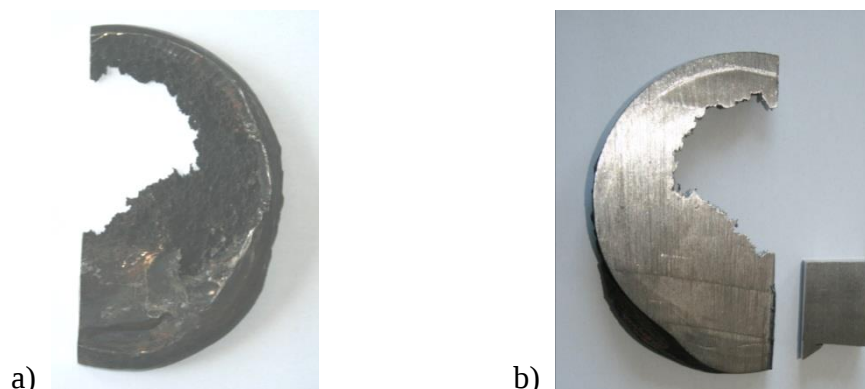
Fig. 12 Segment separated from damaged part of rotor.

On the left side of Fig. 12a is apparent area of fatigue failure and final crack caused by force. On the right side is a crack (Fig. 12b, failure in material) resulting from imperfect technology of shaft production. Strong plastic deformation along circumference of failure cross-section shows that in transversal macrocrack at the same time acted high normal stresses leading to plastic deformations during cyclic loading caused by rotation of turbine rotor.

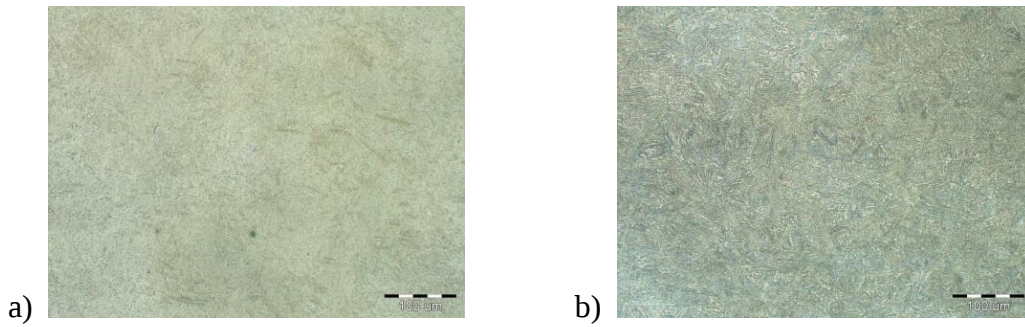
Fig. 17 a) View to microstructure in direction of shaft, b) view to microstructure in direction perpendicular to the axis of shaft.

Microstructure consists of tempered martensite-sorbit that arose out during tempering of martensite over temperature 600°C. In general, the highest fineness of sorbit, the highest strength and hardness [9]. The documented state shows that the technology of temperature processing was appropriate.
