## Experimental Analyses of Limit States, Stress-Strain Distribution, Defects and Failure Mechanisms of High-Pressure Gas Pipe

**Abstract.** The paper contains results and discussion of a comprehensive experimental programme aimed at evaluation of limit states, stress-strain distribution, defects and failure mechanisms of a section of high-pressure gas pipeline taken from an actual line of the nominal diameter DN700, made of an L290NB steel (API 5L X42 steel), operated at maximum pressure 6.1 MPa, with the aim to confirm the service safety and reliability. The experiments were performed using both laboratory specimens machined from the pipe and full scale pipe section of the length 3820 mm. During the full-scale pressure test, the pipe destruction occurred at pressure 12.7 MPa, which is considerably higher than theoretical failure considering the biaxial loading. The pipeline in these conditions was therefore evaluated as safe with a safety factor more than 2. It should be, however, pointed out that the final destructive crack was not initiated in the area of minimum wall thickness as expected, but at the dent with an evident assistance of the surface small cracks. Therefore, an a

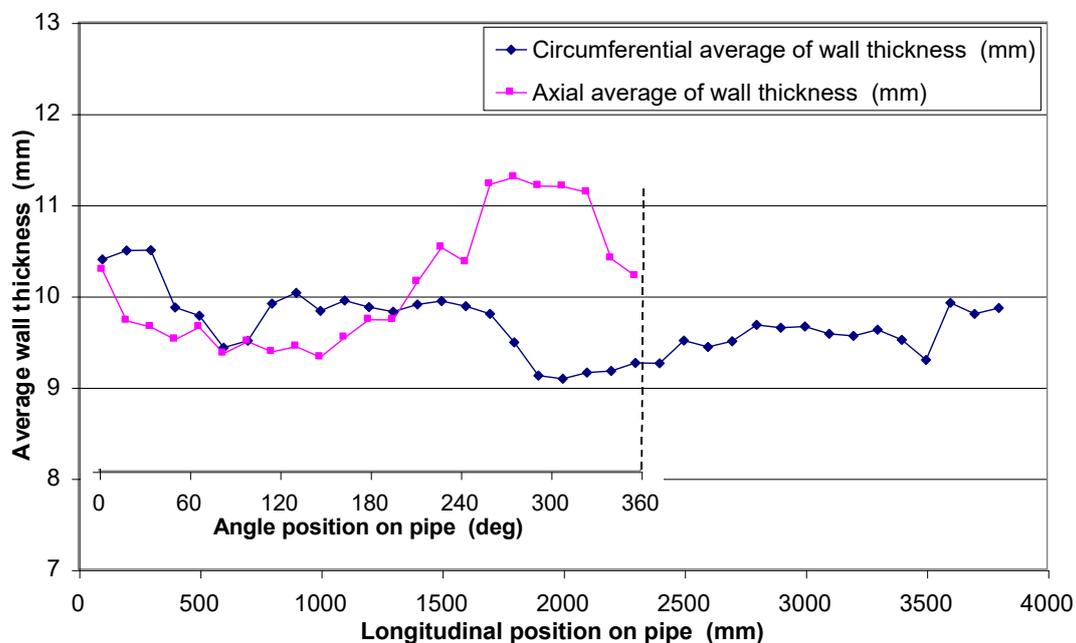
It follows from Table 1 that there was an area of approximately 800 mm in diameter with wall thickness less than 9 mm, namely around 8.5 mm, the minimum value being 8.41 mm. This thickness is almost by 12 % lower than minimum allowed thickness for this type of pipe. Furthermore an angle dependence of wall thickness follows from Fig. 1, where

circumferential differences of the thickness are more than 2 mm, which is a considerably high value. The angle position of minimum and maximum wall thickness is 180° which confirms that the thickness inhomogeneity occurred during pipe manufacture – the pipe was seamless and rolled. The average value from all the measured points was 9.74 mm. Though this thickness is just 0.2 mm above the minimum requested value, the average thickness would be acceptable provided that it was uniform, which was not the actual case.

Fig. 1 Longitudinal and wall thickness distribution

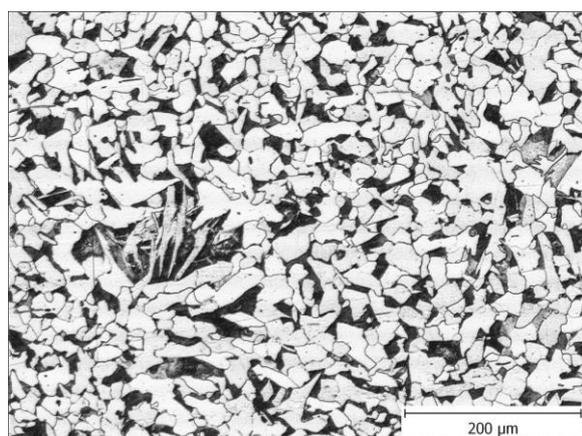
**Metallographic Analysis.** Microstructure was evaluated using an optical microscope Neophot II. Microstructure was of ferritic-pearlitic type. Residues of casting structure could be randomly found – Fig. 2, which can be considered as microstructure defects. Ferritic grain size evaluated according to ČSN EN ISO 643 corresponded to 6-7. Concerning material purity, oxide content was low unlike content of sulphides evaluated according to ČSN EN ISO 4967, which was at the end of the scale limit, perhaps even above it. Decarbonization to 0.2 mm depth was visible near both outer and inner surfaces – Fig. 3. Quite frequent were inclined cracks of length up to 0.5 mm, which occurred likely during manufacture – rolling.

Fig. 2 Ferritic-pearlitic microstructure with residues of casting structure

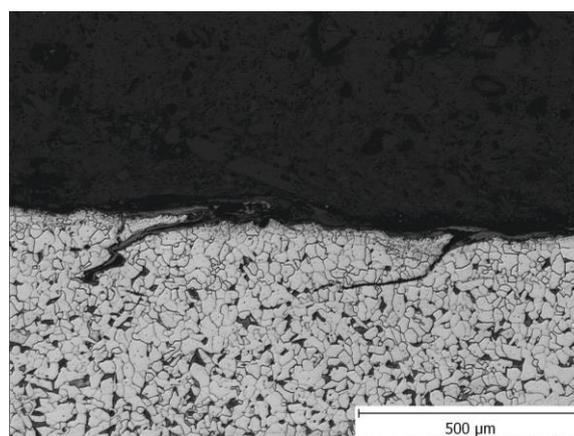
Fig. 3 Decarburized surface with cracks

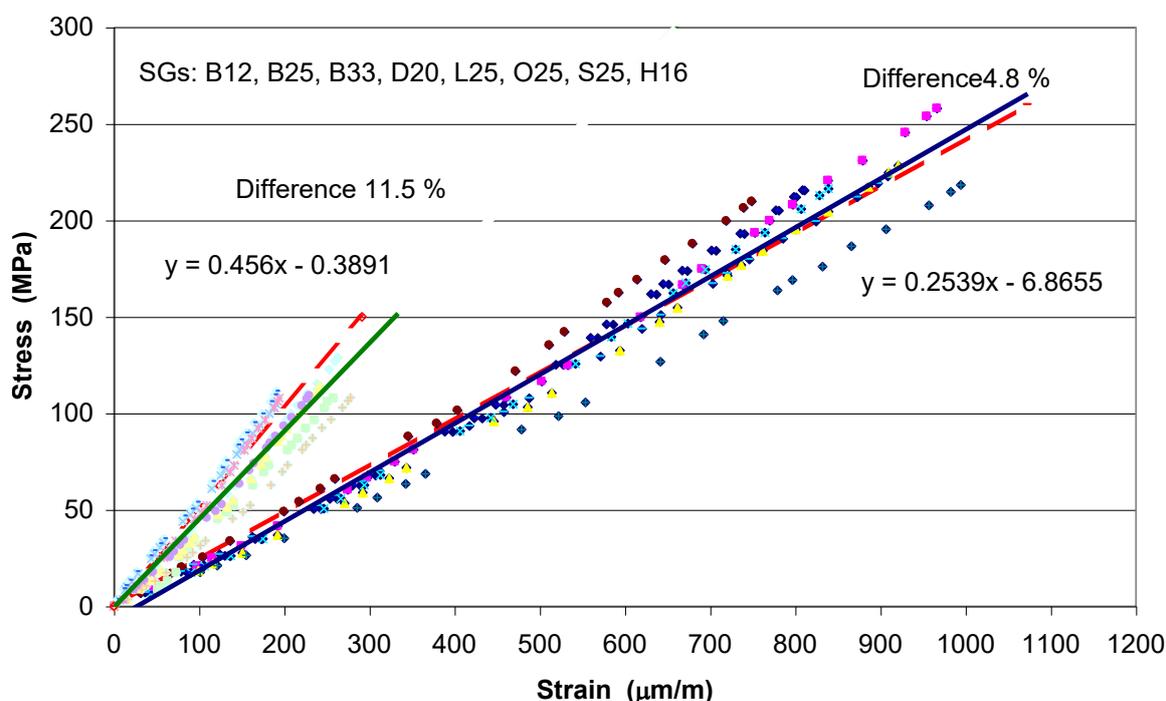
Fig. 4 Total survey of stress-strain dependencies with exclusion of measurement at defects

In Fig. 4, there is quite a good agreement between the regression line corresponding to circumferential measurements, the difference being below 5 %. As regards longitudinal measurement, the difference between the regression and theoretical lines is considerably higher, almost 12 %, the actual strains being higher. This fact can be, however, explained. Most of longitudinal measurements were carried out near the line B, i.e. near the top line. The tested pipe was not supported on rollers but just on wooden cross beams near the pipe margins, which partially obstructed free longitudinal motion at the pipe bottom. This eventually resulted in a kind of additional bending, when bottom strains were below average and top strains higher than average.

Much bigger differences are those between results measured at individual points and theoretical mean values. The differences are up to  $\pm 15\%$  and even up to  $\pm 25\%$  for circumferential and longitudinal measurements, respectively. Such differences cannot be explained by different wall thickness only. The likely reason is a more complex stress-strain redistribution in the pipe due to the variable wall thickness.

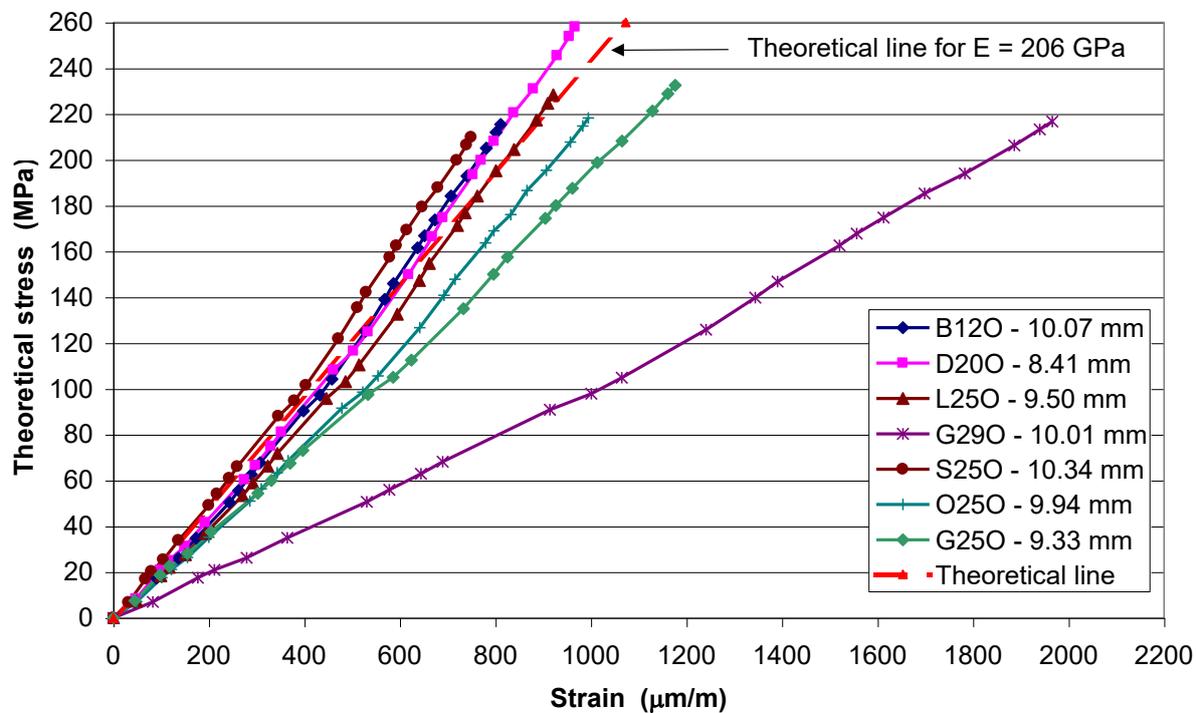
Fig. 5 Stress-strain dependences of selected circumferential measurement points including the two dents

Stress-strain dependences of selected circumferential measurement points including the two dents are shown in Fig. 5. It is evident that strains at the centre of the larger dent were more than 2.3-times higher in comparison with theoretical values for undamaged wall. Note that the dent actually was shallow, almost invisible, with the depth less than 5 mm and diameter approximately 100 mm. Some increased strains were measured at the centre of the second, quite negligible dent.

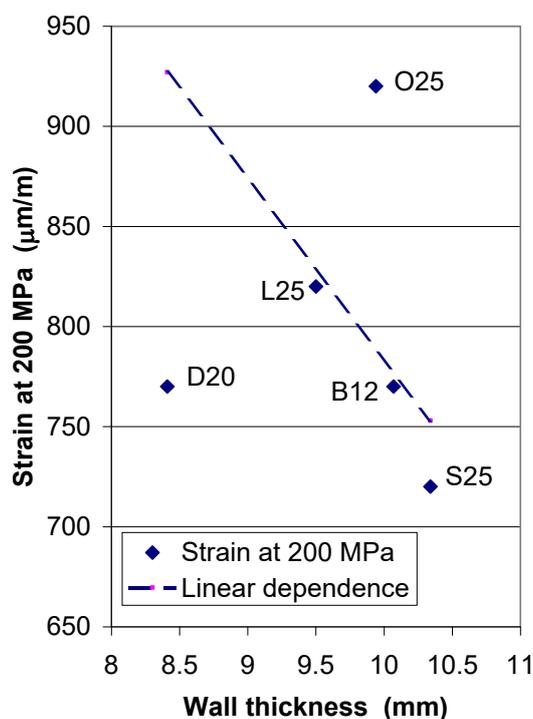
Fig. 6 Strains at 200 MPa at selected measurement points

Individual values of strains at the stress 200 MPa, except the two dents, are shown in Fig. 6. This figure confirms that actual stress-strain distribution was more complex than it would correspond just to different wall thickness. If the strain only was dependent on the wall thickness at corresponding measurement point, the points would lie at least approximately along the linear line. This concerns only the points L25, S25 and B12. Strain values at points D20 and O25 are far from this ideal line indicating that the stress-strain distribution is much more complicated.
