Different types of damages of glued laminated timber beams

MELZEROVÁ Lenka^{1,a} and ŠMÍDOVÁ Eliška^{1,b}

¹CTU in Prague, Faculty of Civil Engineering; Department of Mechanics; Thákurova 7,
16629, Prague 6, Czech Republic

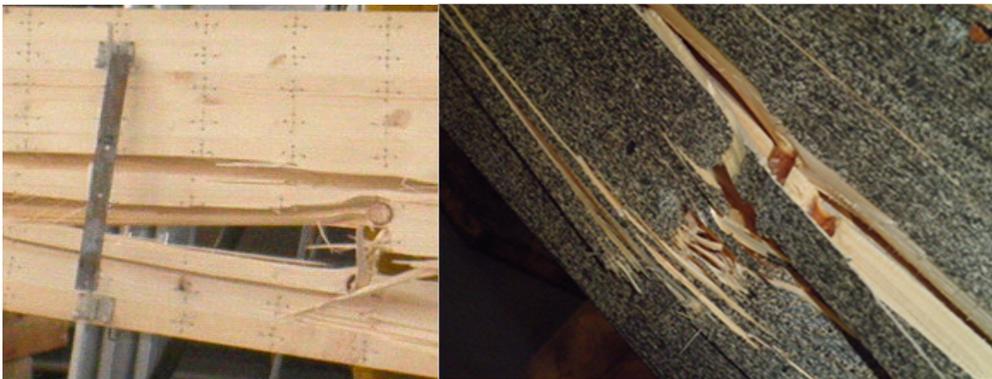
Two detected types of glued laminated timber beams failure are as follows. The first type of failure is a longitudinal crack. This crack usually begins at the point of knot or other wood defects always in the tensile area (Fig. 1). Cracks have always propagated through individual laminations and their transition from one ply to the other was smooth regardless of the horizontal glued surfaces.

Fig. 1: A longitudinal crack

This type of beam failure is exceptional. Large knots are removed during the production of glued laminated timber. The load needed for its creation is extreme. The second, more frequent type of failure is the destruction of the finger joint, which is located at the lower edge of the beam in its middle third (see Fig. 2).

The damage caused by the oblique cracks is always initiated by the knot or other damage to the wood. The knot area ratio (KAR) is significant for this type of damage, which is part of existing research following the well-known Karlsruhe model.

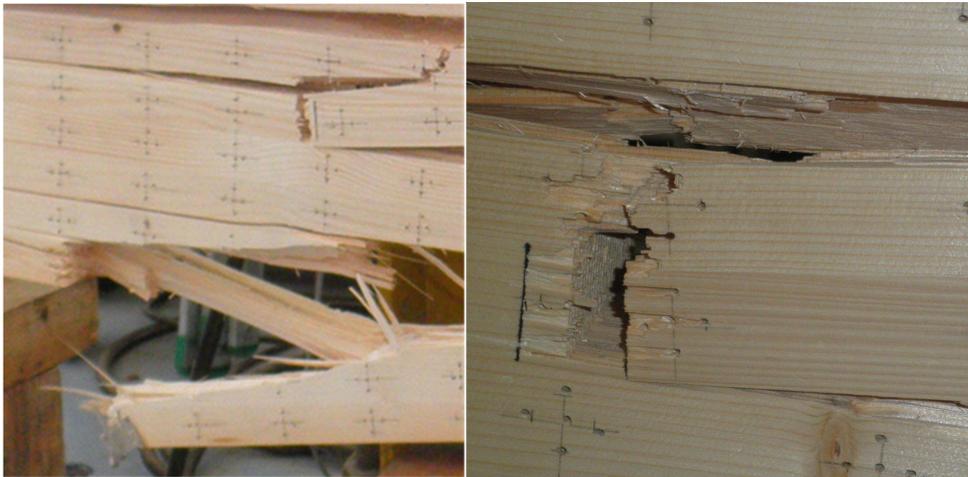
Fig. 2: Destruction of the finger joint

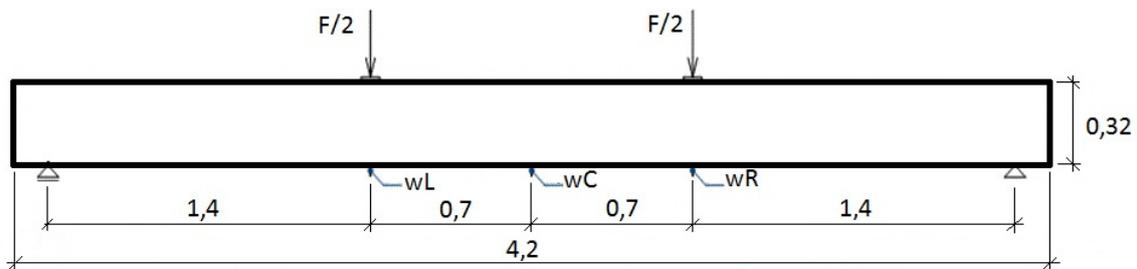
Fig. 3: Example of tested beam
