## Jindřich KRATĚNA<sup>\*</sup>, Martin ŠPERL<sup>\*\*</sup>, Shota URUSHADZE<sup>\*\*\*</sup>

# DAMAGES TO FACADE PANELS – THEORY AND EXPERIMENTAL VERIFICATION

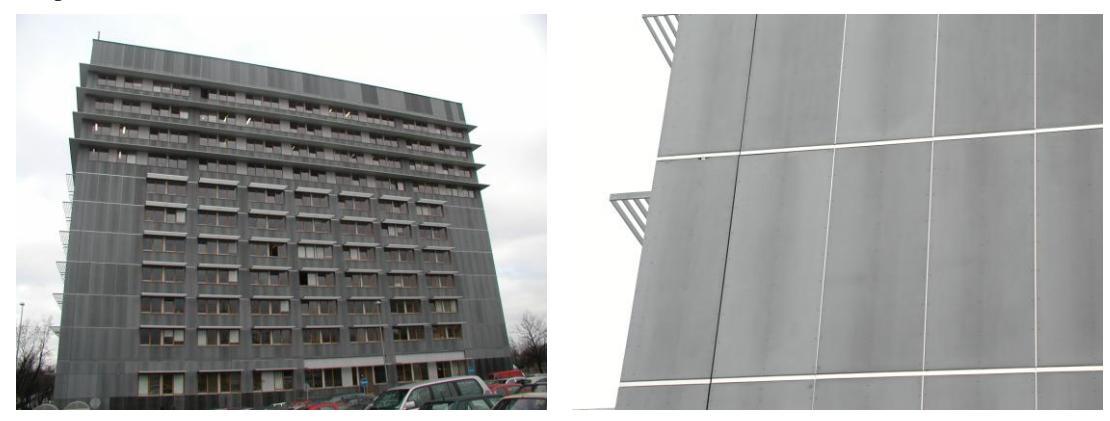
The facade of the building (Fig. 1) was clad with Cembonit FDA cladding sheets 8 mm thick, of dark grey colour, sized 1200 x 3050 mm (Fig. 2), installed in September to November 2003. Their first destructions took place in the Summer months, further in the Summer of 2005. In exceptional cases these destructions concerned also newly installed sheets replacing the damaged ones.

The expert assessment drafted at the request of the installation firm states that a major number of the sheets is damaged by cracks passing mostly through the rivet across the sheet corner, that the greatest occurrence of damaged sheets was ascertained on the southern face of the building, that the sheets were fastened to a frame of aluminium sections by explosion rivets, that these rivets were missing in some solitary places, that in the places of sheet corner separation the rivet shaft was deformed to a C and even S shape and that rivets of 5.5 to 6.4 mm diameter were found in the environs of the building. In conclusion the expert states that the damage is due most probably to volume changes and obvious sheet deformation after insolation and that in April 2005 the sheet supplier issued a change of specification which changed very significantly the installation conditions in the manner enabling sheet expansion on the framework and that it is obvious, consequently, that he (the supplier) had realized the unsuitability of instructions given in the technical manual for cladding sheet installation in force since April 2003.

Fig. 1 View of the building facade

Fig. 2 Cembonit FDA cladding sheets

Experimental verification agreed with theoretical calculations. Therefore, it was possible to conclude that the initial installation instructions drafted by the sheet manufacturer and prescribing the hole diameter of merely 7.5 to 9.0 mm were in direct causal relation with the damage to the cladding sheets on the building. The author of the instructions obviously underestimated the approximately double thermal expansion of aluminium with reference to steel. Apart from that he underestimated the fact that the dia. 4.8 mm explosion rivets increase their diameter to 6.4 mm during their application. Consequently, the installation firm did not cause the destruction of the cladding sheets by its work. The installation according to new instructions prescribing dia. 10 mm holes should not cause the tearing-off of sheet corners, unless the installation is carried out at extremely low temperatures.
