Fatigue Behaviour of Bolted Joints without Load Transfer

Martin Kadlec^{1, a}, Ivan Mlch^{1, b} and Roman Růžek^{1, c}

¹VZLU – Aerospace Research and Test Establishment, Beranových 130, Prague,
Czech Republic

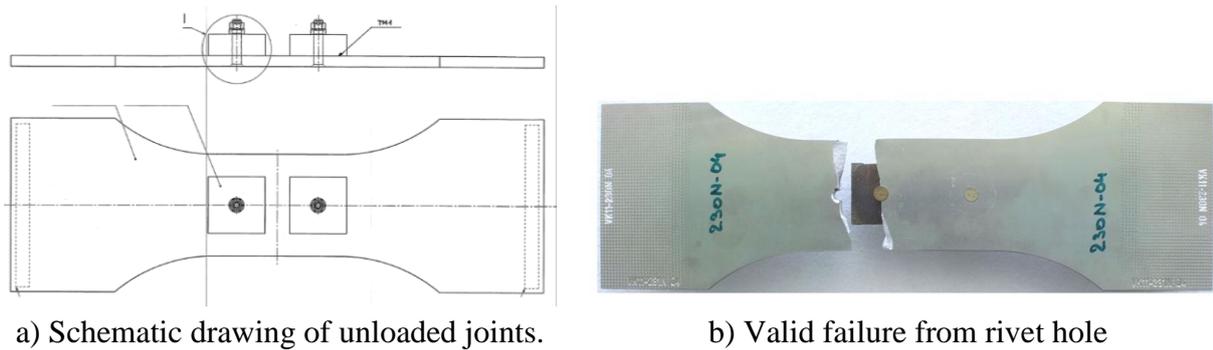
Fig. 1: Unloaded joint schematic and a failure mode

where A_1 , A_2 and A_4 are the regression constants and $(\sigma_{br})_{MAX}$ is the maximal stress level of the load cycle applied to the specimen gross cross section. The linear model was used as Eq. 1 with $A_4 = 0$. Fig. 1b shows the obtained two valid Wöhler curves. The other curves were not evaluated due to invalid failure modes.

- 1) Fracture initiated from the fastener hole which was considered as the only valid failure. The top surface view is included in Fig. 1b. The fracture surface in Fig. 3a shows radial crack growth from the fastener countersunk;

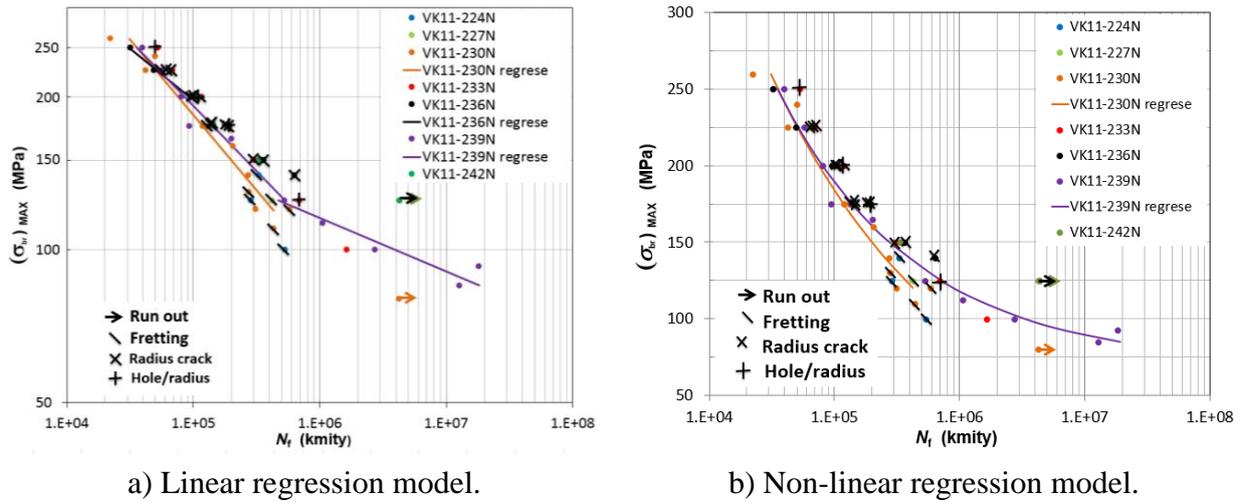
The fatigue data are also marked according to failure type that is described in the following paragraph. No point crossing means valid crack initiation from the hole. Fig. 2 shows summary of the fatigue lives including linear and non-linear regressions. The linear regression was split into two parts because of different slope for load below 120 MPa.

Fig. 2: Results of fatigue crack growth of unloaded joints.

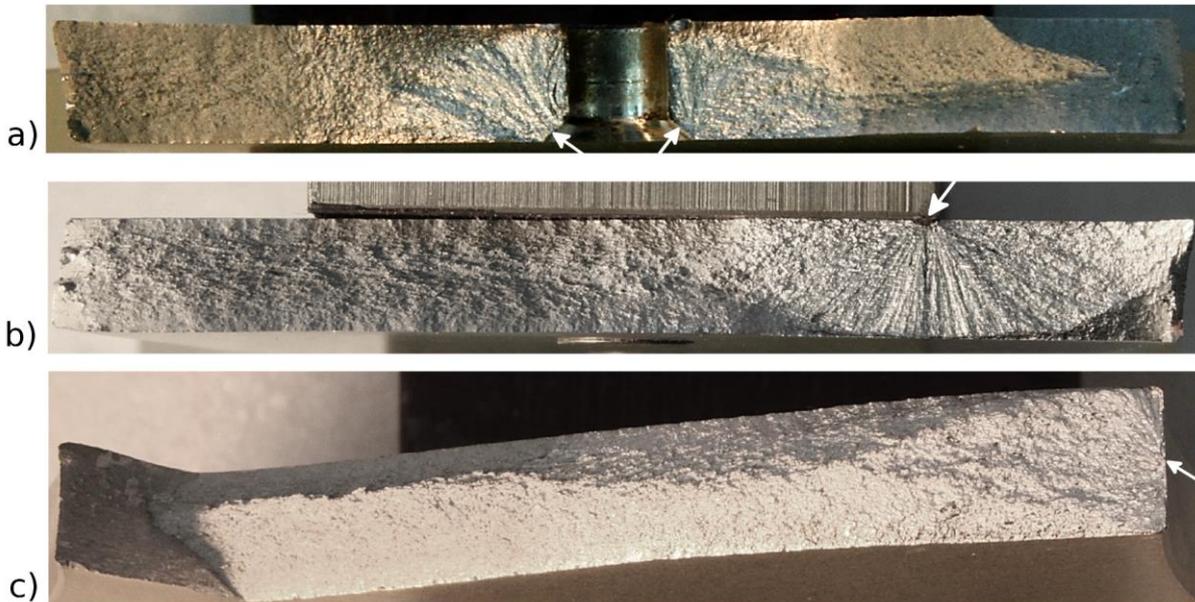
- 2) Fretting corrosion between main and opposite part was observed only for the Hi-Lite fasteners (Fig. 3b). The fretting initiated not only from the opposite block corner but also from its edges.
- 3) Specimen radius crack initiation, more preferentially for higher load levels over 150 MPa (Fig. 3c).
- 4) Longitudinal cracking. It was observed for specimens with the radius initiation and it appeared only for main parts extracted in LS direction.

Fig. 3: Typical failure observed during testing: a) hole initiation, b) fretting corrosion, c) radius initiation.

There is a possibility that some of radius failed specimens had already hole initiated crack. Detailed non-destructive inspection of holes (after joint disassembly) was not performed. This idea is supported by the fact that the radius initiated fatigue lives were not significantly

different from the valid failure modes. However, a combination of radius initiation and fretting corrosion was confirmed on several specimens. Testing of series with high ratio of the invalid failure modes was interrupted. The specimens with other than hole crack initiation were not included to the evaluation.

1) Design modified specimens with a large or double radius (larger radius near the gage section) to prevent radius crack initiation.

2) Use lower cycling frequency for Hi-Lite bolt specimens to prevent fretting which can be done on the remaining specimens. Some additional research activities are needed.
