39th International Conference

June 4 - 6 , 2001 Tábor, Czech Republic

CONTACT-LESS METHODS FOR IDENTIFICATION OF COHESION LOSS IN LIME MORTAR RENDERS

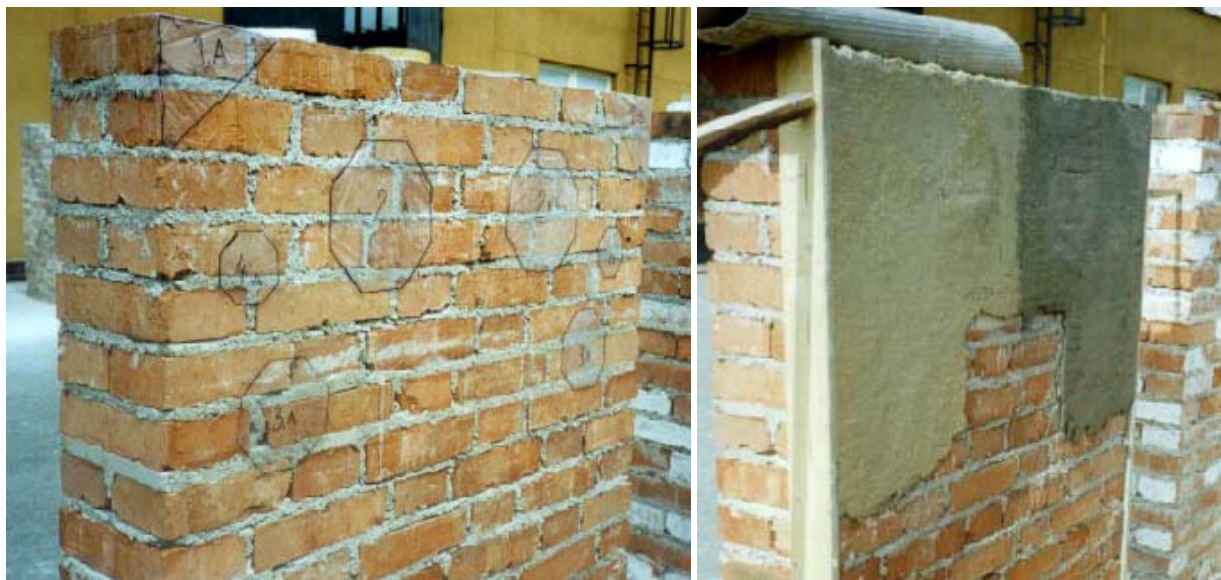
The method has been tested in laboratory on brick walls bearing an imperfectly fixed plaster specimens or plaster layers. The rendering had to possess mechanical characteristics as close as possible to the historical plasters. Therefore, it has been made of a lime mortar composed of lime and quartz sand in volume ratio of 1 to 5. There were made two testing walls. On the first one, a prefabricated layer of plaster of dimensions approximately 20 cm by 30 cm, with thickness of 4 mm was partially fixed to the wall along by two strips of special mortar [3]. The second was rendered by two types of lime plaster – poor lime mortar and lime cement mortar. Here were made artificial defects using separation of rendering by means of thin plastic foils, Fig.1a,b.

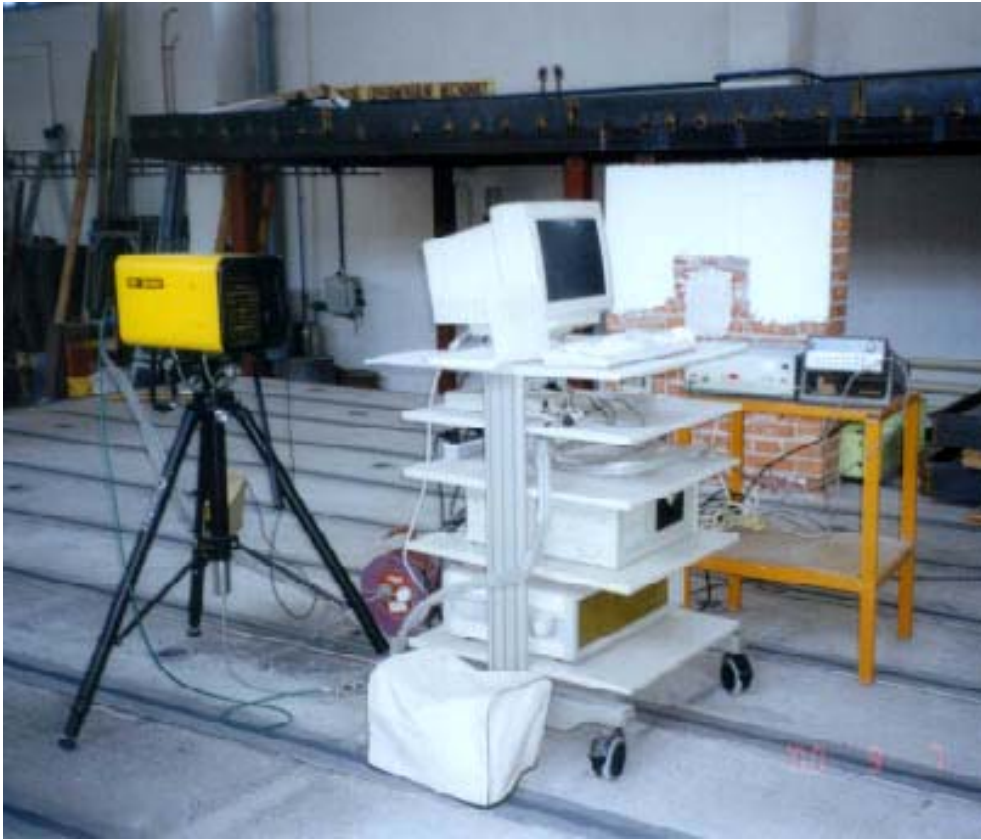
The vibration was introduced into the test specimen from an electromagnetic exciter and transmitted through a thin rod connected to the wall. The vibration frequencies varied continuously from 40 to 1500 Hz and the natural frequencies were determined. Under those frequencies, the velocities were scanned across the measured field which was a rectangle with dimensions of 234 mm by 262 mm, in the first case. In the second case, the full rendered area

was scanned. The intensity of excitation generating the maximum velocity of about 5 mm.s^{-1} was used. The experimental set-up is shown on the Fig. 2.
