# The Reliability Verification and the Actual Dynamic Behavior Assessment of an Existing Footbridge

**Abstract:** The dynamic experimental and theoretical analysis that is described in this paper was focused to the footbridge across Vltava River in Prague which was built in 1984. The footbridge was evidently sensitive to dynamic excitation by passing pedestrians since its putting into operation. Moreover during its existence the substantial part of the footbridge was overflowed by two great floods in August 2002 and June 2013 and an evident damage on the deck was found by a visual inspection after the second flood. At first the experimental modal analysis was performed. Secondly the dynamic load test focused to the footbridge vibrations caused by different groups of pedestrians was carried out. It was found out the deck vertical vibrations exceed the pedestrian comfort limit in some situations. Based on comparison of evaluated modes of natural vibrations with the appropriate ones from previous experiments, it was confirmed that the detected damage caused the partial variation of dynamic footbridge behavior.

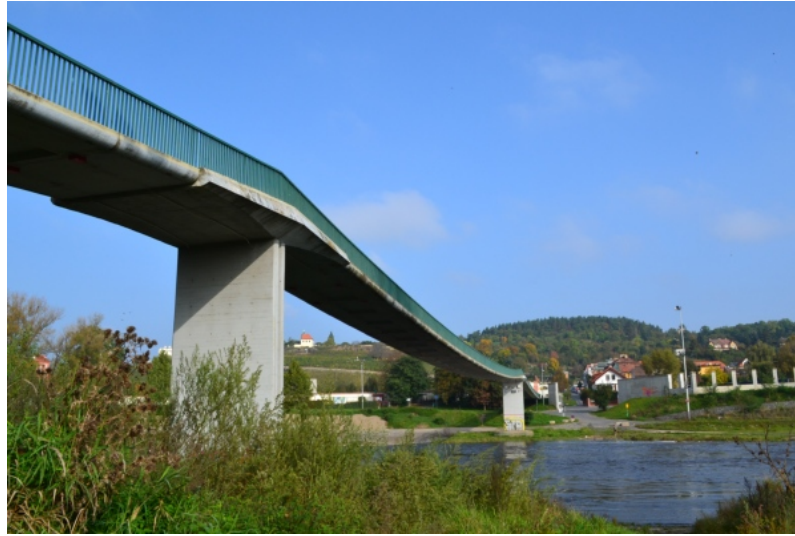
The footbridge across Vltava River in Prague (see Fig. 1) is made from the prestressed concrete. The bearing structure is the stress ribbon bridge with three spans 85.5 m, 96.0 m and 67.5 m (see Fig. 1). The

Fig. 1: The overview on the investigated footbridge.

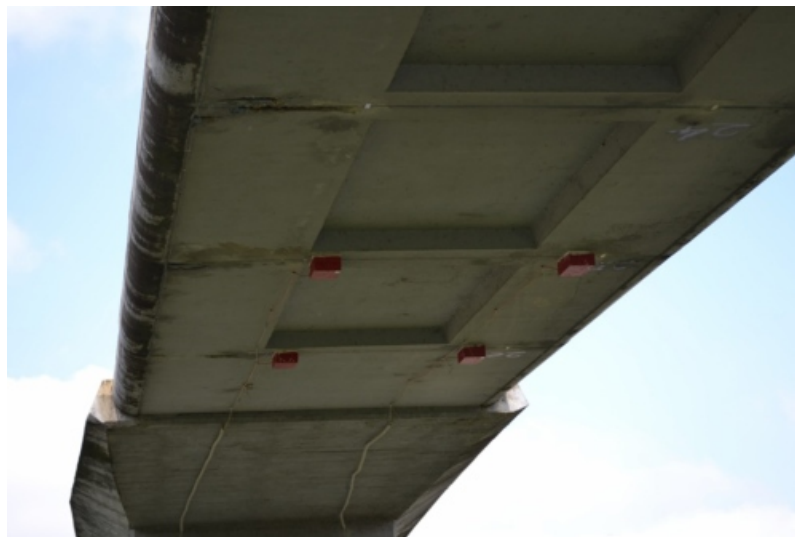
footbridge deck is composed from precast segments DS – L and DL – Lv that are made from concrete B500 (see Fig. 2) and from the monolithic saddle which are located upon both of two intermediate piers (see Fig. 1 and Fig. 2).

Fig. 2: The bottom view on the footbridge deck.

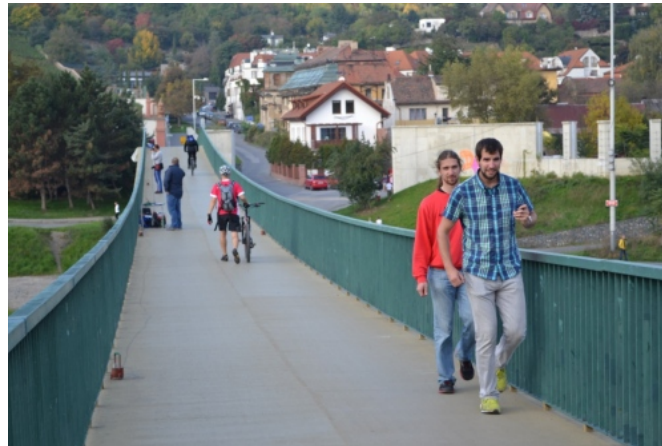
The force vibration of the footbridge deck was studied during the second part of the experiment that was caused by different groups of pedestrians. The footbridge deck vibrations were observed by a normal pedestrian traffic, walks of two pedestrians (see Fig. 3) and actions of vandal groups for example. All walks of two pedestrians and actions of vandal groups were synchronized at resonance with some natural frequency of the deck (see Fig. 3) the attention was focused on the footbridge natural frequencies around 2.0 Hz especially.

Fig. 3: The walk of two pedestrians synchronized at resonance with the ninth natural frequency 2.05 Hz.

The force vibrations were observed in three deck points only (see Fig. 3). Two points were placed in the cross section in the middle of the main footbridge span where the vertical vibrations were observed in both points and the horizontal ones in one point. The third point was situated at the quarter of the main span and in this one the vertical vibrations were investigated only. The same measurement system, device and transducers, were used as by the experimental modal analysis.

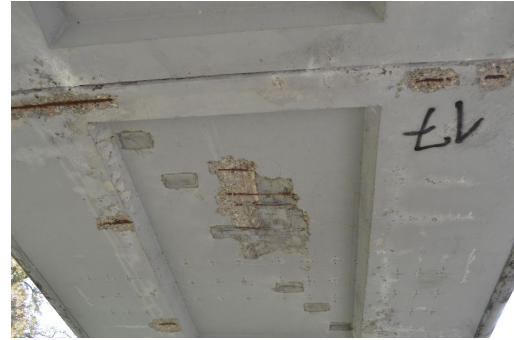
Fig. 13: The damage detected on the deck after its partial repair.

It was stated in [2] that the similarity of the natural mode shapes measured in 2010 and in 1997 was high. On the other hand, some differences were found out between the natural mode shapes from 2013 and 2010, especially in the area where the evident damage was found on the deck, which is located approximately in the middle of the first span. It was confirmed that similar differences were detected between natural mode shapes from 2014 and 2010. The detected damage on the deck also after its partial repair caused the partial variation of dynamic footbridge behavior.
