Industrial Compressor Impeller Strength Evaluation

Abstract: Impellers are for our company subject of experimental stress analysis, because are the most important parts of the compressors. All information about impellers are key to the development of our company, therefore is testing of impellers our integral part.

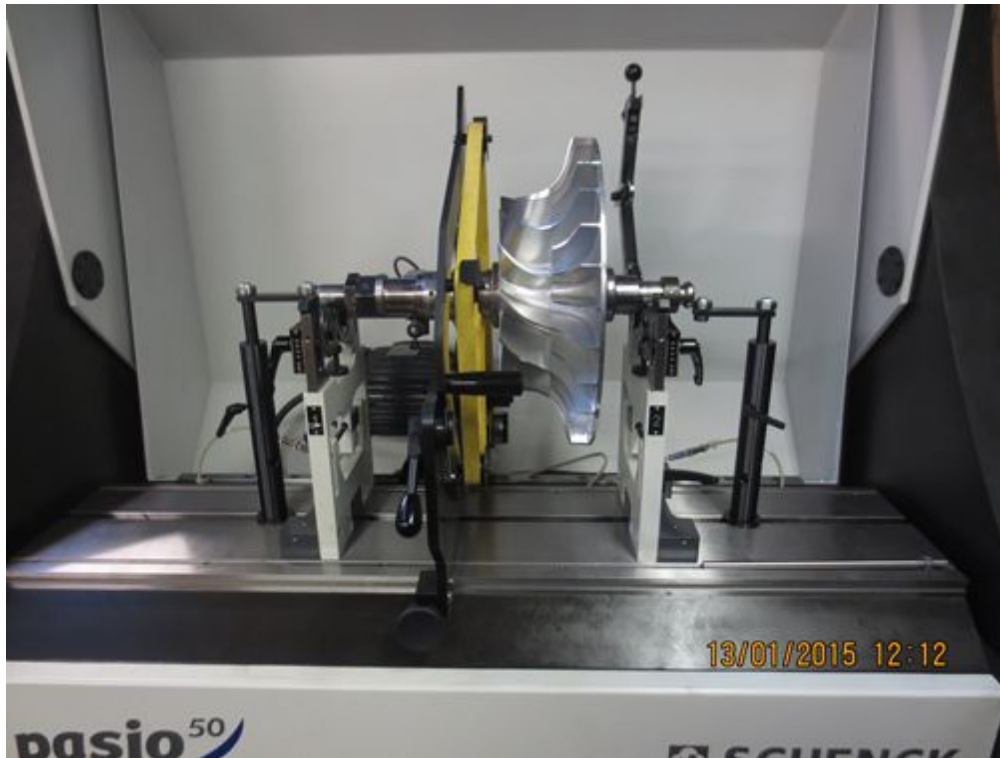
Fig. 1: Low-speed balancing machine.

For better properties of impellers and balanced rotation of train, the impellers are balanced. The impellers are usually balanced by taking away some material from the impellers. For this process of determination the best properties of impellers, a balancing machine is used, Fig. 1.

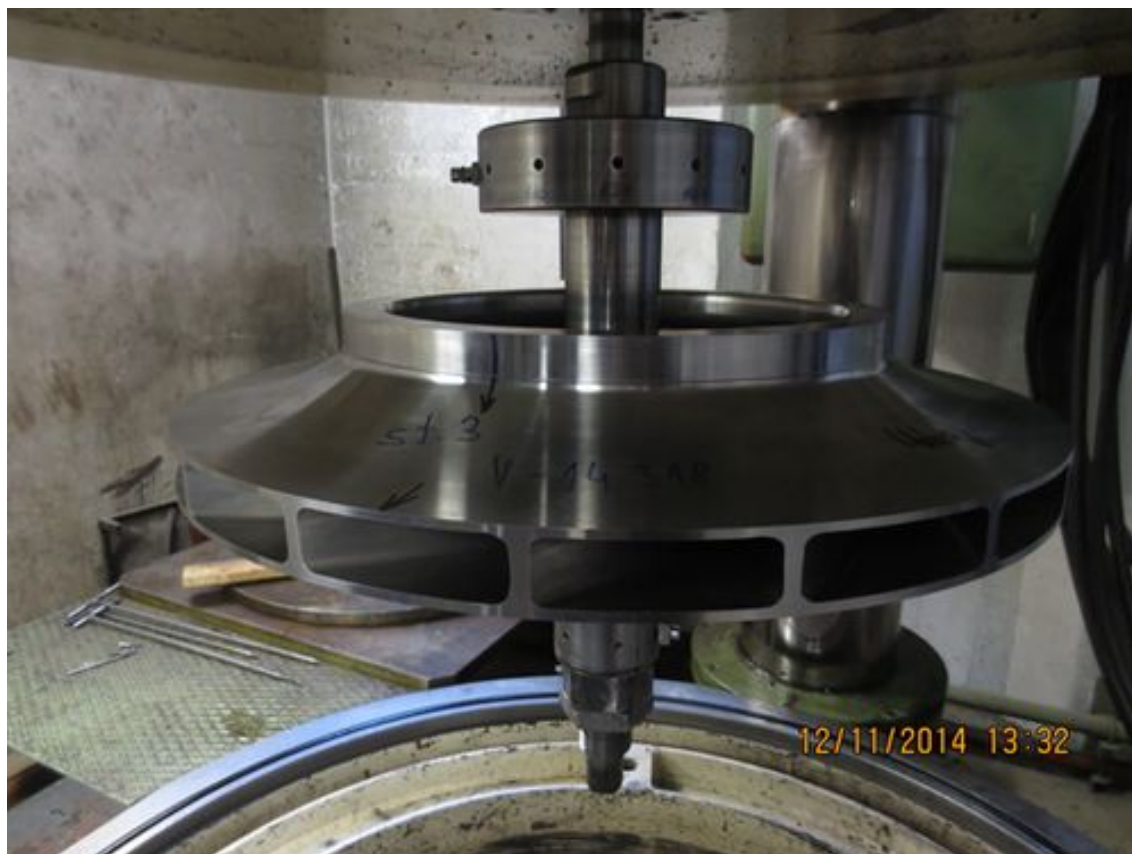
Fig. 4: Over-spin testing.

Each manufactured specimen is tested in laboratory. A non-destructive testing is performed consequently. Sustaining of the over-spin gives potential to be operated without failure.

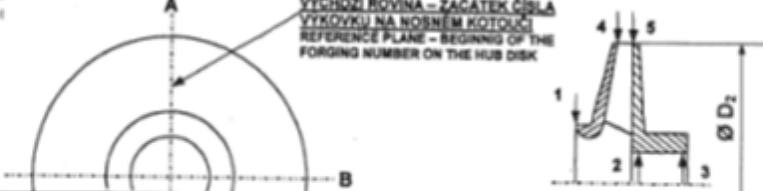
Měřené místo Measurement point	1 2 3 4 5
Připustná trvalá deformace Permissible permanent deformation	0,000 09. D2 min. 0,03 mm
Připustná trvalá deformace Permissible permanent deformation	0,000 11. D2 min. 0,04 mm
Průměry před odstředěním Diameters before overspeed test	A 305,030 153,500 152,310 454,070 454,030
Průměry před odstředěním Diameters before overspeed test	B 305,050 153,500 152,310 454,090 454,050
Průměry po odstředěním Diameters after overspeed test	A 305,050 153,500 152,310 454,080 454,050
Průměry po odstředěním Diameters after overspeed test	B 305,050 153,500 152,310 454,110 454,070
Teplota měřeného kola před odstředěním Temperature of measured impeller before overspeed test	°C
Provedl Performed	
Teplota měřeného kola po odstředěním Temperature of measured impeller after overspeed test	°C
Datum Date	23.4.2015
Podpis, razítko Signature, stamp	
ODSTŘEDĚNÍ KOLA Maintenance Partners – 101J-HD STAGE 1 IMPELLER

Fig. 5: Test report balancing, overspeed testing and dimensional check of impeller 1/2.

Example of test report balancing, overspeed testing and dimensional check of impellers is shown in attachment.
