## Experimental stress analysis of critical locations in vicinity of frame welds of hospital sickbeds

**Abstract:** Hospital sickbeds are being used not only for accommodation of patients, but also for ensuring the optimum position of inpatients during handling, therapy and connected investigations. Safety and reliability of the sickbed frames is one of the essential conditions for everyday use. An investigation programme on prevention of potential fatigue failures of welded joints between sickbed shackles and cross girders of the frame was carried out. The problem of the weld joint between the shackle and frame consisted in very different thickness of the two parts, the shackle thickness being approximately 10 mm in comparison with very thin wall of the cross girder resulting in potential weld imperfections. Fatigue cracks could be then initiated as a result of cyclic loading during road transport, when frames are usually stacked on each other, particularly in countries with poor quality of pavement. Results of experimental static and dynamic strain/stress measurement near the locations of welds are presented and discussed considering potential weld imperfections. Taking account

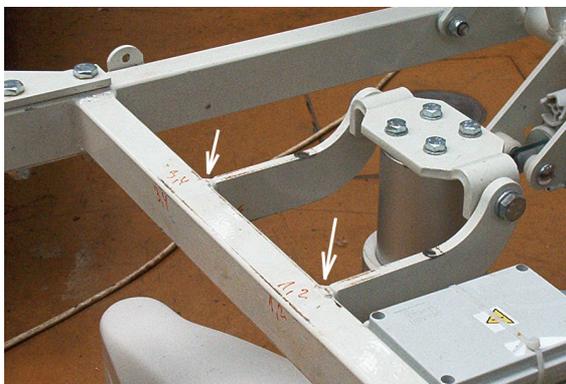
The paper contains the most important result of a case study connected with an occurrence of cracks in essential structural elements of sickbed frames, having arisen in welds between bed frame cross girders and plates attaching the frame to the positioning hydraulic cylinder – Fig. 1. The critical welds are indicated by arrows (compression zones), whereas the cracks arose in zones of tension loading – at the bottom opposite to the arrows. The cracks occurrence was observed in several cases after transport of the bed frames on bad quality roads, when beds were stacked on each other. Attention was paid particularly to quality analysis of the welds. In the second part of the paper, extensive experimental static and dynamic stress analyses were carried out to evaluate actual possible strains and stresses occurring in the critical sites. A prototype strengthening device to prevent possible fatigue cracking was then proposed and its positive effect on reduction of dynamic stresses was demonstrated.

**Fig. 1.** Sickbed frame with welds between cross girder and plates, the critical welds being indicated by arrows (compression zones).

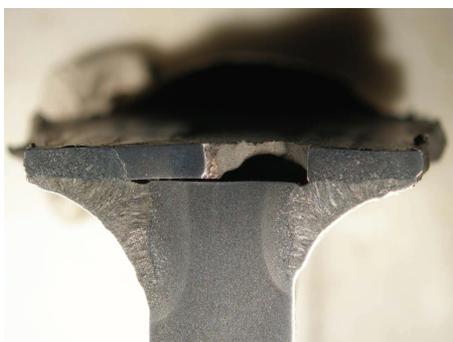
A sample of the weld delivered to the laboratory was sectioned and metallographical analysis carried out. Macro view of the perpendicular cut of the weld is in Fig. 2 showing the 2 mm thick wall of the girder (horizontal position in Fig. 2) and the 8 mm thick plate – vertical. bottom part of Fig. 2. The right part of the weld is of a relatively good quality unlike the left part, where imperfections were found.

**Fig. 2.** Macro view of perpendicular cut of weld.

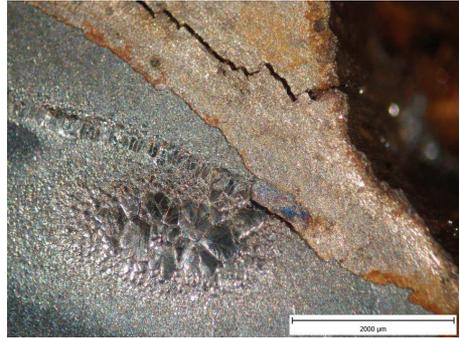
Fractographical analysis showed that crack propagation was gradual, i.e. of fatigue type – Fig. 3. However, fatigue crack propagated under the contribution of existing technological welding cracks and other defects including microstructural ones. Welding cracks were found particularly in heat affected zone along boundary between fine grain and Widmannstätten structure, which is typical for low carbon steels, if overheating is followed by fast cooling – Fig. 4. The cracks likely arose as a result of residual stresses. Besides these technological cracks, melting zones in the thin walled girders were found, usually containing further cracks at their boundaries – Fig. 5. It is therefore evident that the welding parameters were not ideally optimised.

**Fig. 5.** Coarse melted structure with technological crack at zone boundary.
