## Verification of the strength of the composite propeller blade retention by means of strain-gauge measurement

**Abstract:** The fitting of the composite blade in the propeller hub represents probably the most critical part of the propeller. Its sizing directly influences the weight characteristics of the propeller, operating reliability and safety of the entire design. The completed strain-gauge measurement confirmed the estimated sequence of failures in the overloaded node leading to the final fracture. It has also provided an interesting theme for possibilities of monitoring the design status during operation in the very part which is hard to inspect by conventional non-destructive methods.

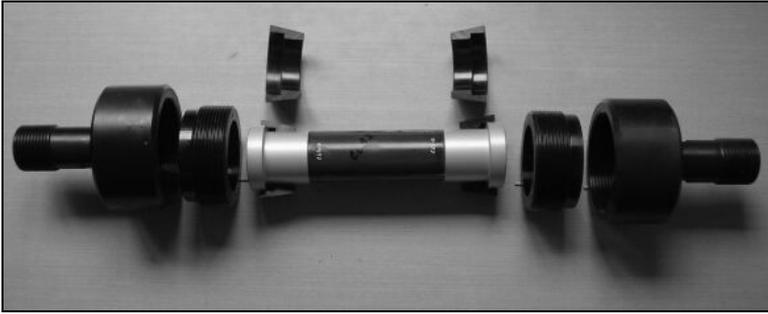
**Fig. 4.** Test piece, “double-root” type, for testing the static strength of the joint.

Figure 3 illustrates a typical design of the propeller hub which makes use of the aforementioned shape lock in the blade design. The static strength of the propeller blade retention node is subsequently tested by means of the so-called “double-roots”; see Fig. 4. Identical retention node is formed at both ends of the cylindrical test piece made of composite; the node is exposed to a pure tension gradually all the way to the fracture; see Fig. 5.

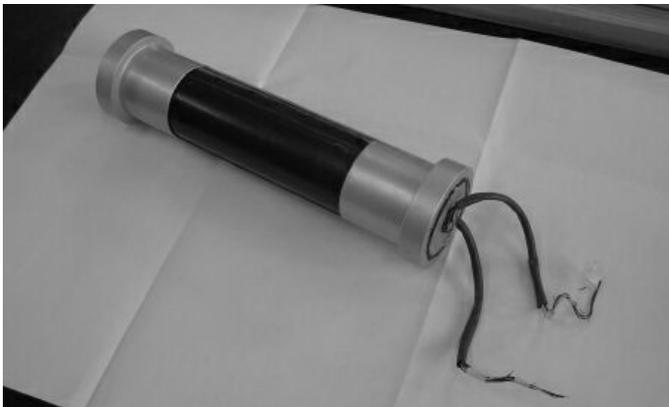
**Fig. 11.** Test piece manufactured with the use of the RTM technology, with ducts from strain gauges located on the inner surfaces of the metal parts.
