# Influence of Cutting Conditions on Surface Integrity after Progressive Grinding of Blade Roots from Inconel 713LC

**Abstract:** The goal of this article is to describe changes of properties after progressive grinding of blade roots from Inconel 713LC. Especially, surface residual stresses were studied as a function of different grinding conditions and microstructure of bulk material. Residual stresses of surface layers were determined by using X-ray diffraction techniques.

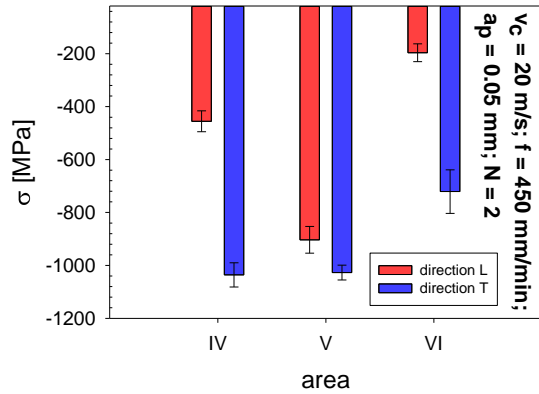
Fig. 2: Distribution of RS on the surface of the side B affected by grinding burns.

On the surface of several blade roots, the grinding burns were found, see Fig. 5. The grinding burns resulted in decrease of compressive RS values which are depicted in Fig. 2. The grinding burns were caused by insufficient cooling during grinding and probably by grain size and its orientation. The grinding burns were primarily detected on the edges of roots, as a result of a smaller amount of material for heat distribution<sup>1</sup>, see Fig. 5. The anisotropy in polycrystalline samples is generally reduced more in comparison with single crystal, because of the distribution of crystal orientation. It means that in the case of coarse-grained material, there may be a grain which is oriented in a direction with smaller thermal conductivity parallel to the heat flow [7]. These grains may cause grinding burns.

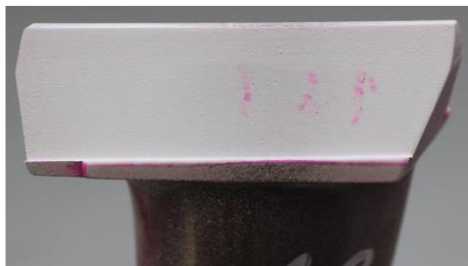
Fig. 6: Blade root with line indications of defects determined by capillary testing.

The sharp decrease of compressive RS on the surfaces for several blades was explained by metallographic cross sections obtained by capillary test through which, the cracks were found, see Figs. 3, 6 and 7. Regardless of the compressive RS in the surface layer 4-5 microns thick of ground roots, it is possible to expect that there are tensile RS in the deeper subsurface layers [8]. These RS have a negative effect on the functional characteristics of the blade roots and probably could cause cracks.

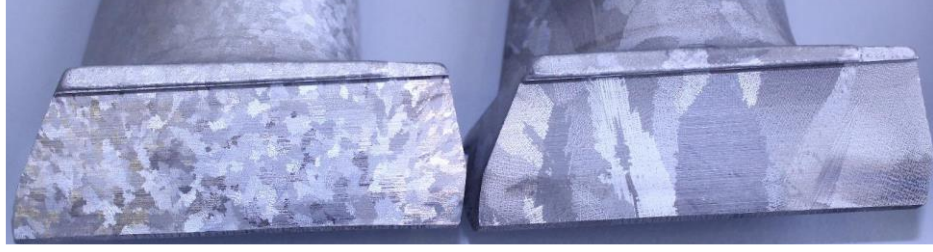
Fig. 8: Fine-grained and coarse-grained microstructure of bulk material of selected samples.

The rest of inhomogeneity were probably caused by coarse-grained microstructure of bulk material, see Figs. 4 and 8, which enables to predict that slip directions of several grains are parallel to the primary grinding force. Therefore, even smaller force could cause the slip and thereby smaller compressive RS are determined.
