# The Stress Detection and the Fatigue Lifetime of Stainless Steel AISI 316L during Three-Point Bending Cyclic Loading

**Abstract:** The article will describe investigation of the deformation of stainless steel during three-point bending cyclic loading with using thermovision. The analysis will prove different temperature response to external loading and dependence of elastic or plastic deformation development on material's state. The input data which are necessary for this analysis we will can get from temperature field of specimen surface. Process of elastic and plastic deformation is in dependence on radiation emitted by the object. For obtain thermal fields we will use thermal camera FLIR SC7000 with the highest sensitivity. The contribution also presents results of fatigue resistance of austenitic stainless steel AISI 316L, which is used as a biomaterial, obtained at low frequency cyclic loading in the high cycle fatigue region by three- point bending test. The fracture surface of the testing sample was examined using scanning electron microscopy (SEM).

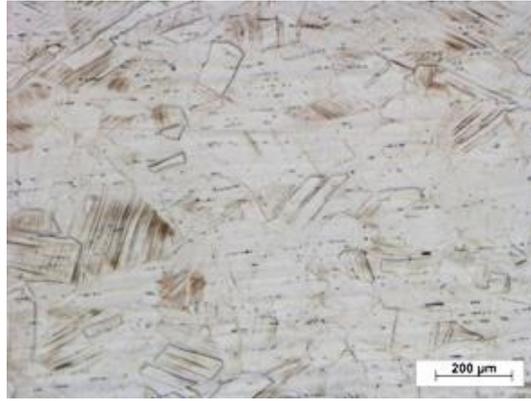
Fig. 1: Microstructure of AISI 316L

For our analysis we used a commercially available type of austenitic stainless steel, especially AISI 316L. Its microstructure is shown in Figure 1 and its chemical composition is listed in the Tab. 1

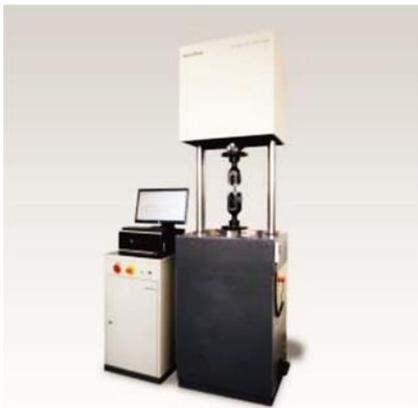
a) vibrophores Amsler 150 HFP 5100

Stress and fatigue testing are common test methods in mechanical engineering and materials science, but provide limited information on complex structures. For three-point bending cyclic test, we used Vibrophores Amsler 150 HFP 5100 (Fig. 2a), which is using the resonance principle with constant or variable amplitude and mean load. The testing specimens were cut from rectangular bar to dimension of 10x10x55 mm and a V-notch was placed in the middle of the testing bars. First all the testing bars were preloaded with -6 kN and then cyclic loading was applied on the testing bars. After the test, the numbers of cycles were recorded as a dependence of frequency change from number of cycles for all the testing specimens.

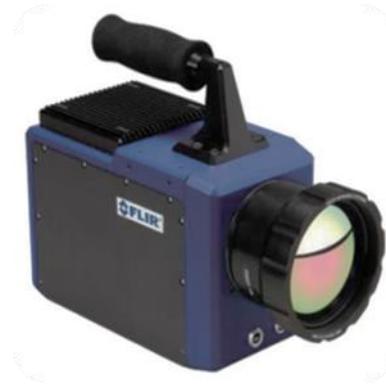
b) thermal camera FLIR SC7500

Thermal stress mapping provides thousands of stress measurements simultaneously, even on geometrically complex components. The deformation of structural materials is followed by thermal effects. For obtain thermal fields we used thermal camera FLIR SC7500 (Fig. 2b). It is very flexible camera, with high sensitivity, accuracy, spatial resolution and speed. The results of monitoring fatigue test by thermal camera are shown in Figure 3a and Figure 3b.

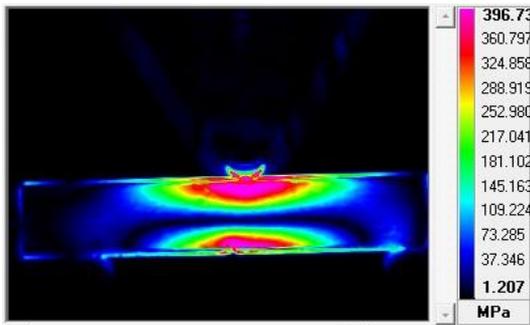
a) at the beginning of the test

Fig. 3: Results from thermal camera for AISI 2136L during three-point bending test

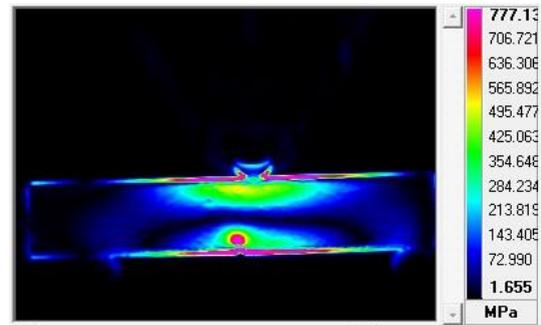
b) before the end of the test and after cracking

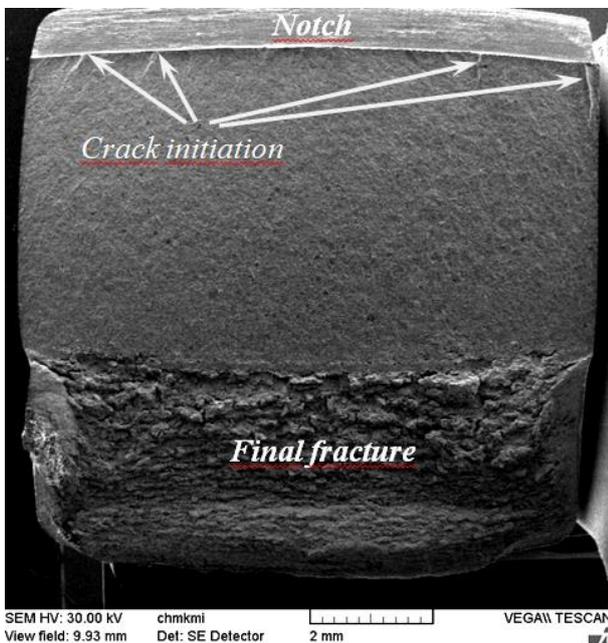
Fig. 4: Fracture surface of AISI 316L testing bar with several initiation sites, three-point bending fatigue

The fracture's surface of the testing sample was observed by SEM. In Figure 4 is seen the macrophoto of the fracture area. After fatigue test, several initiation sites were observed under the notch, as shown in macroscopic view (Fig. 4). In Figure 5 is shown a detail of one initiation site. Also a line of cyclic deformation strengthening was observed on the fracture surface close to the final fracture. The fracture has mix fracture modes predominantly created by ductile separation with dimple morphology and also brittle intercrystalline facets, with the size of app.  $50 \times 90 \mu\text{m}$ , occur in the fracture and it can be seen in Figure 6 (with a detail of deformation strengthening line before final fracture in Figure 7). The intercrystalline facet was examined also on the opposite site of the sample's fracture as it can be seen in Figure 8 and Figure 9 where one site consists the salient and the opposite one consists the hollow.

A crack was initiated on the testing bar by three-point fatigue bending test. The fracture has originated from several sites under the notch after  $412 \times 10^3$  cycles. The failure in the fracture surface was realized by ductile dimple fracture micromechanism. The dimple dimensions were in a range of 2 - 5 microns. In the fatigue area of the fracture surface the fracture was propagated by striation mechanism. Striation spacing in this area had grown in the range of 2 - 3 µm. The striations had soft corrugated surface. The numerous striations clearly state the fact that the testing sample has failed by fatigue. Inclusions of sulphate type were observed in the structure, mainly in the dimples. On the fracture's surface annealing twins were observed and also various intercrystalline facets with slip deformation.

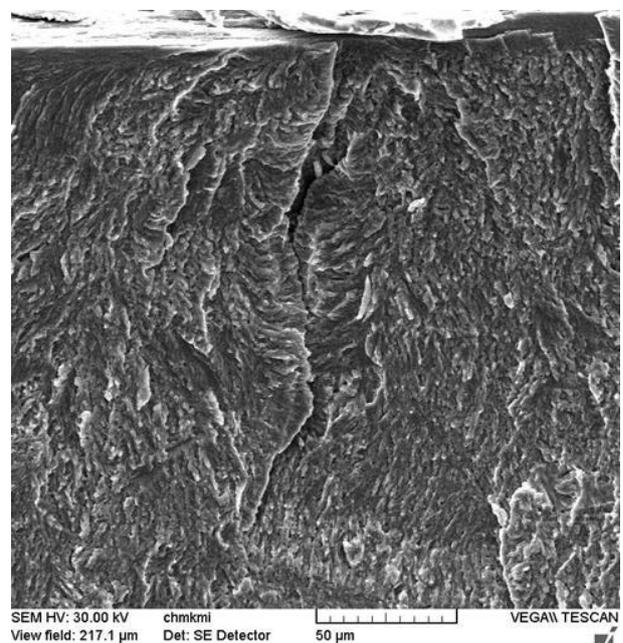
Fig. 5: Detail of one initiation site, AISI 316L, three-point bending fatigue

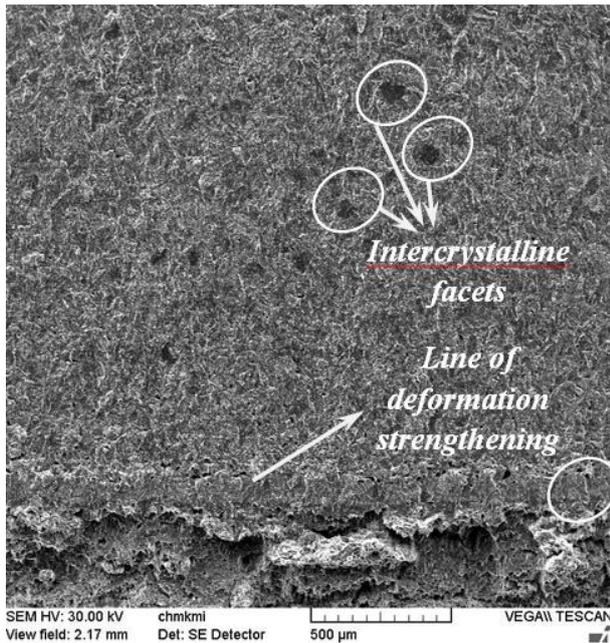
Fig. 6: Fracture surface of AISI 316L, intercrystalline fracture facets, deformation strengthening

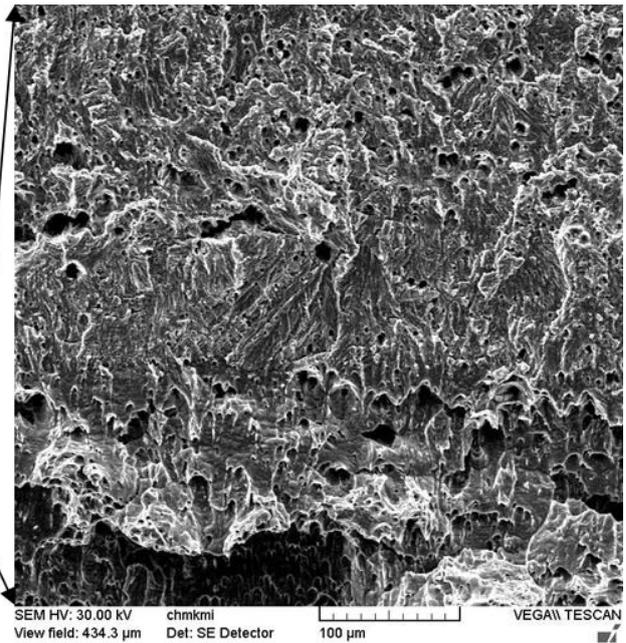
Fig. 7: Detail of deformation strengthening line before final fracture, AISI 316L

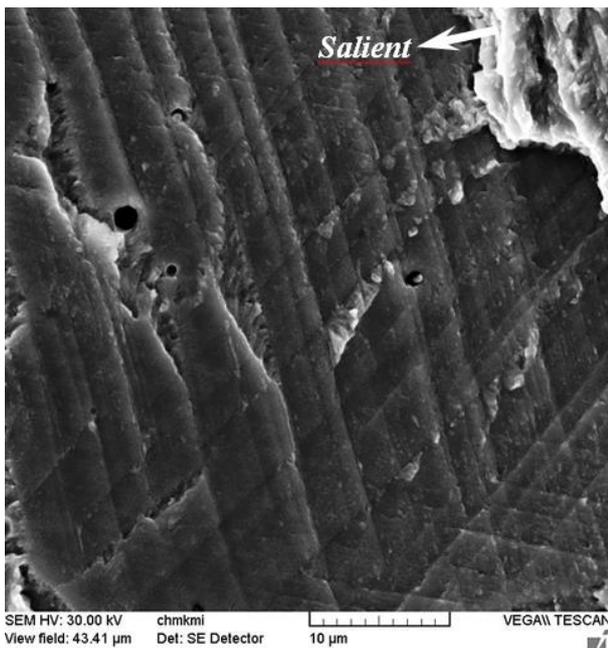
Fig. 8: Intercrystalline facet, right side of the sample

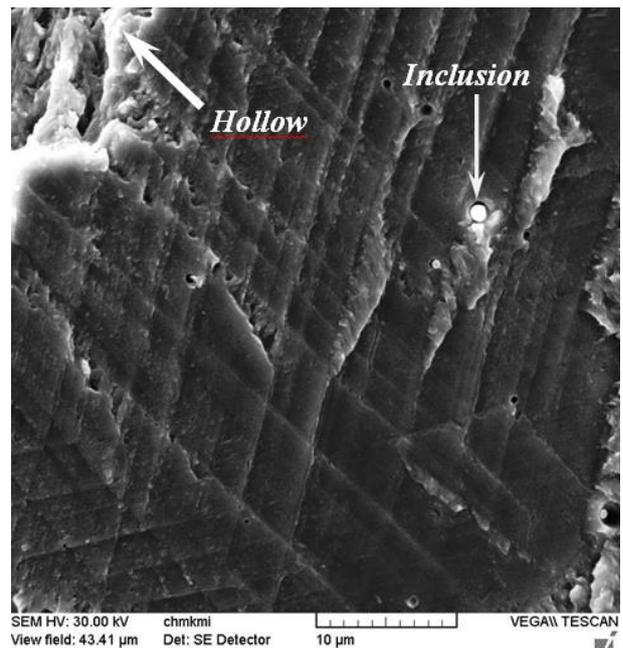
Fig. 9: Intercrystalline facet, left side of the sample
