Determining the causes of the solenoid coils incorrect winding

Abstract: Accurate placement of the wire is required during solenoid coils winding. Because many incorrectly wound coil were produced on the used winding machine, the analysis of this situation causes were to be realized. The winding machine precision measurement and simulation of the wire winding to the coil composite skeleton are described in this article.

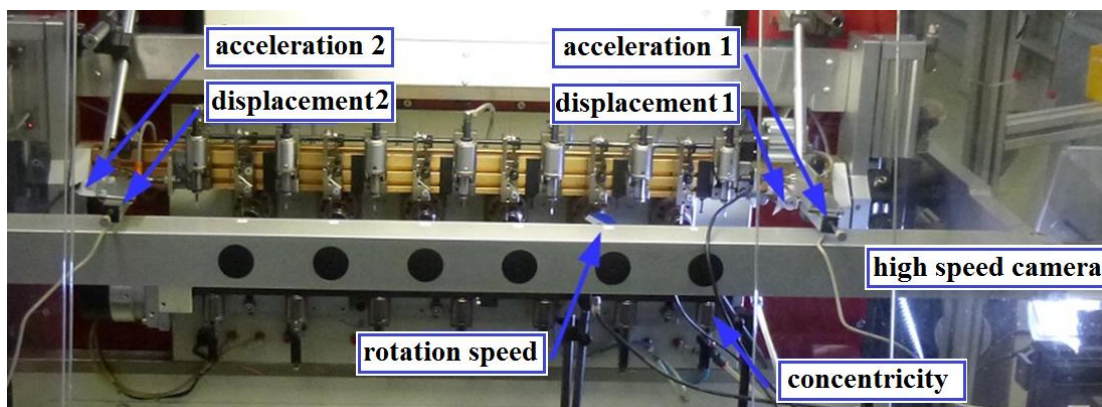
Fig. 2: The winding machine precision measurement.

One of the coils was supplemented by the aperture and rotation speed was measured by the digital laser sensor. Two very precision movement sensors were used for the homing head left and right side movement measuring and its vibrations were measured by two accelerometers as the additional information. One of the coils concentricity was measured by the contactless inductive sensor. The winding process was recorded by the high speed camera too. All sensors signals and the camera movie were synchronized by the Dewe5000 measurement unit [1].

Several cycles with different winding speeds and different head required displacement were measured and no problem with winding machine synchronization and displacement precision was found (see Tab.1).
