## Experimental verification of the mechanical properties of the material of the rotor shaft of the turbine damage

## Description of turbogenerator damage

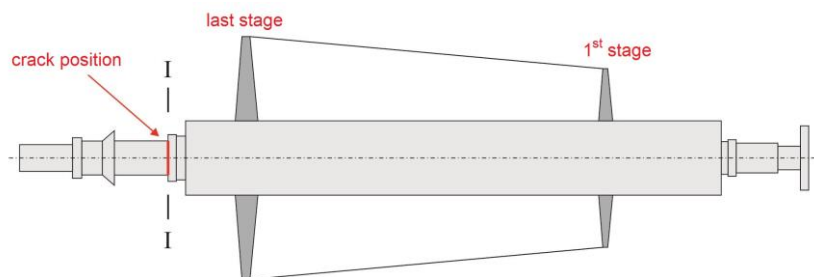
Fig. 2 Shaft of turbine rotor.

The condensation steam turbogenerator before damage is shown in Fig. 1. Analyzed turbine rotor is made of alloy steel, forged as one piece (Fig. 2). The blades processed from anti-corrosive steel are assembled to the discs by special joints.

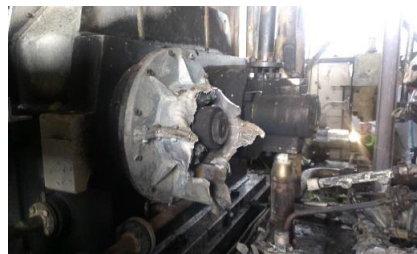
Fig. 5 Part of clutch from the side of reduction gear.

The right side in Fig. 4a represents broken part of turbine rotor shaft from the location damaged by fatigue fracture, while the outer diameter of full shaft is 120 mm in the location of fracture. The left side shows a shaft that consists of a pipe (Fig. 4b) on the end of which is a flange of clutch. View to the second part of clutch (from the side of gear) under aluminium cover is shown in Fig. 5.

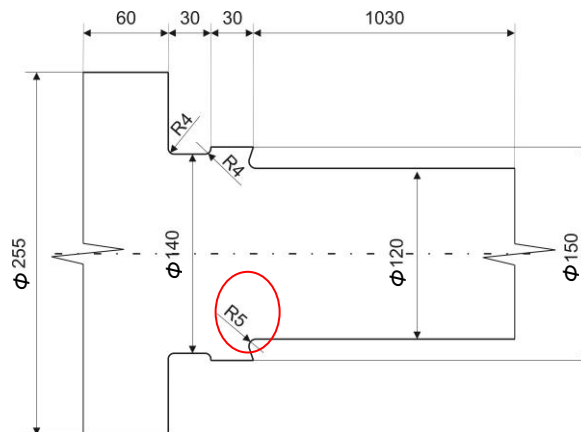
Fig. 10 Dimensions of turbine rotor shaft.

Creation of circular part of fractured surface concludes that it is resulting from combination of bending and torsion where the initial crack was caused not only by high level of equivalent stresses resulting from combination of bending and torsion, but also by stress concentrator due to defective structure of material resulting from smithing, Fig. 9. Such defective part together with sharp angle of relatively non-traditional shape (Fig. 10) localizes the area of first failure of turbine rotor shaft. This area was selected for further analysis of shaft material.

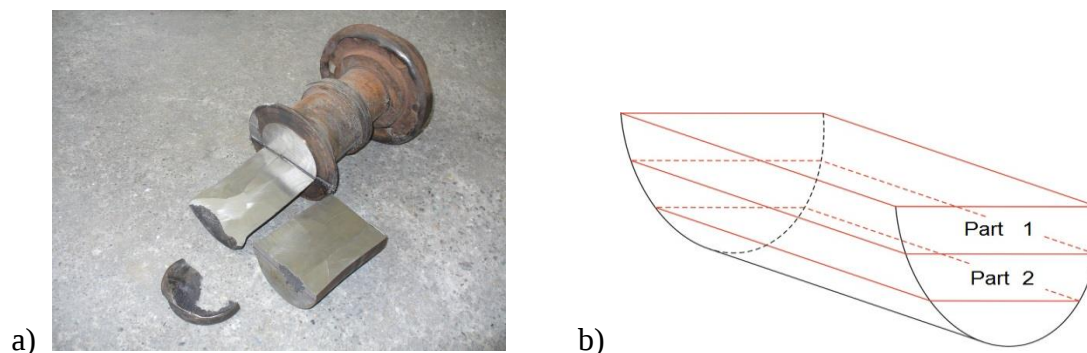
Fig. 11 a) Location on turbine rotor shaft from which was taken the material for tests, b) plan for preparation of specimens.

Fig. 8 documents that during crack spreading the pressing of material occurred which were invoked by cyclic loading resulting from rotation of shaft and axial deformation of flange clutch. In Fig. 11a is shown the separated part of turbine rotor from which a material for tests was taken. The material for mechanical and metallographic tests, see Fig. 11a, was taken according to plan given in Fig. 11b.

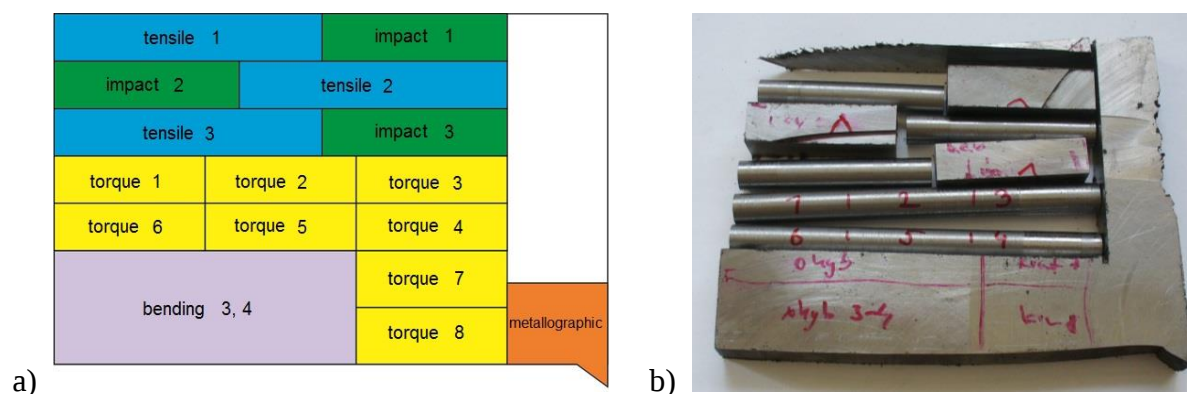
Fig. 13 Plan for preparation of specimens.

The material for mechanical and metallographic tests was taken according to plan given in Fig. 13.

Data scattering can be joined with specific location of specimen take off from the turbine rotor shaft, which was loaded over yield point of material (see Fig. 8 and Fig. 13).

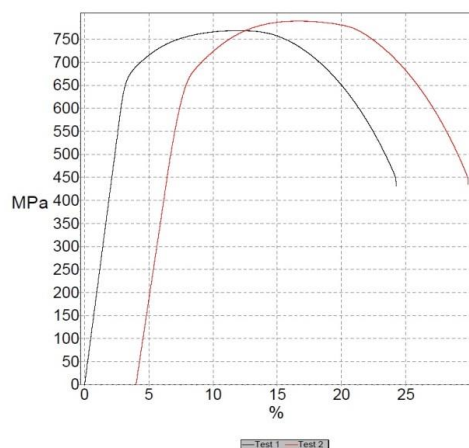
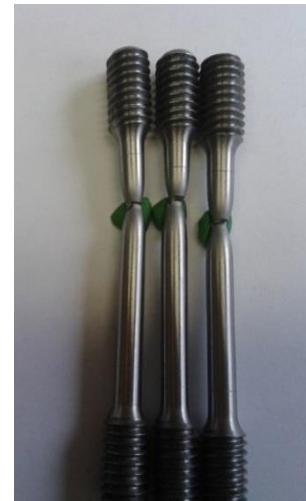
Fig. 14 a) Tensile test diagram of specimens 2, 3, b) damaged test specimens 1, 2, 3.

Average value of yield point  $R_{p0,2}$  was 640 MPa and strength  $R_m$  was 778 MPa. Shapes of tensile diagrams for specimens 2 and 3 are given in Fig. 14a, the test specimens after tests are shown in Fig. 14b.

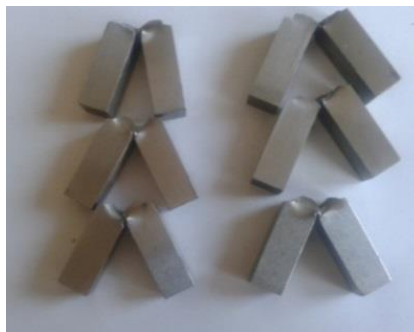
Fig. 16 Damaged test specimens after impact test in bending.

Average value of toughness with notch „V“ is  $\text{KCV}=218 \text{ Jcm}^{-2}$  and with notch „U2“ is  $\text{KCU} = 248 \text{ Jcm}^{-2}$ . Damaged test specimens after impact bending test are shown in Fig. 16.

The measured results show that the toughness of material fulfills demands given in material standard for the steel STN 41 6314.
