CFRP Fuselage Panels Behaviour in Compression

Abstract: This paper describes compressive behaviour of a reinforced fuselage composite panel. Implementation and validation of two types of strain sensors is discussed. Fibre optic Bragg grating (FOBG) sensors and standard resistance strain gauges (SGs) are used for strain history and panel behaviour validation. The mechanical tests includes different load-scenarios – compression to failure of undamaged panel, compression to failure of impacted panel and compression to failure of impacted and fatigued panel. In all cases, the panel failed due to buckling. The measurements taken from the FOBGs captured all changes in the buckling modes of the panel. Moreover, they showed a good correlation with the measurements taken from strain gauges. These findings validate the proposed strain monitoring system.

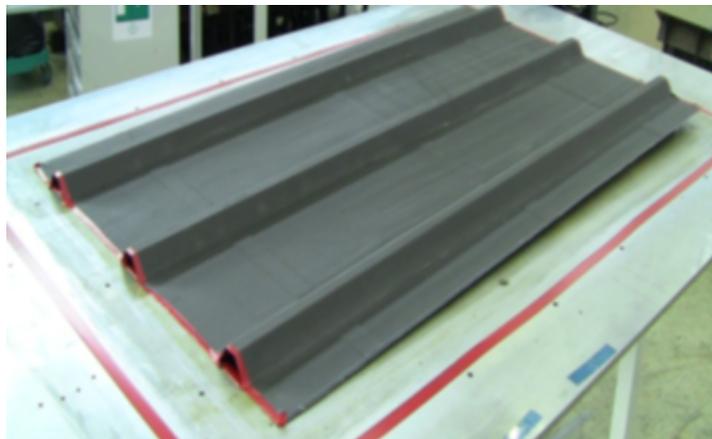
HexPly 8552 (Hexcel), thickness of the prepreg ply of 0.125 mm, was used. The outer dimensions of the panels were 1650×900 mm with stringer spacing of 330 mm. The static/fatigue compression loading scenarios were chosen. Each of the panels contains different number of defects and different level of impact damages (from flaw free to visible impact damage configuration). Both barely visible impact (BVID) and visible impact damages (VID) were applied. Manufactured reference composite stiffened panel is shown in Fig. 1.

Fig. 1: Composite stiffened panel.

Three stiffened composite panels were used to evaluate the sensor behaviour. Each panel consists of the skin thickness of 2 mm, three omega (Ω)-shaped stringers, and three ribs thickness of 1.5 mm. The unidirectional

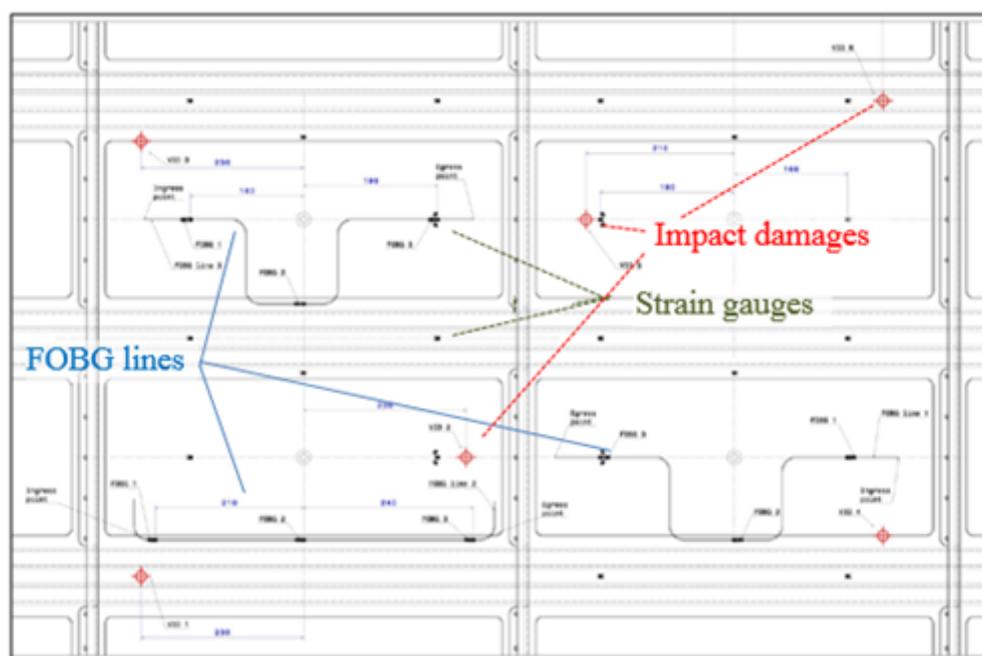
An FOBG sensor network was designed to enable the measurement of strains that are related to the basic damage patterns developed in the panel during loading. In each of the three panels, nine FOBGs were mounted following a configuration of three sensors per line. The sensors were bonded externally or embedded into the structure. The wavelengths of the sensors at each array were 1526 nm, 1547 nm, and 1568 nm, respectively. In the similar way, approximately seventy strain gauges (SG) were mounted on each panel. Fig. 2 shows an example of embedded FOBG routing, SG placing and damage location.

Fig. 2: Definition of FOBG sensors, strain gauges and impact damages location.

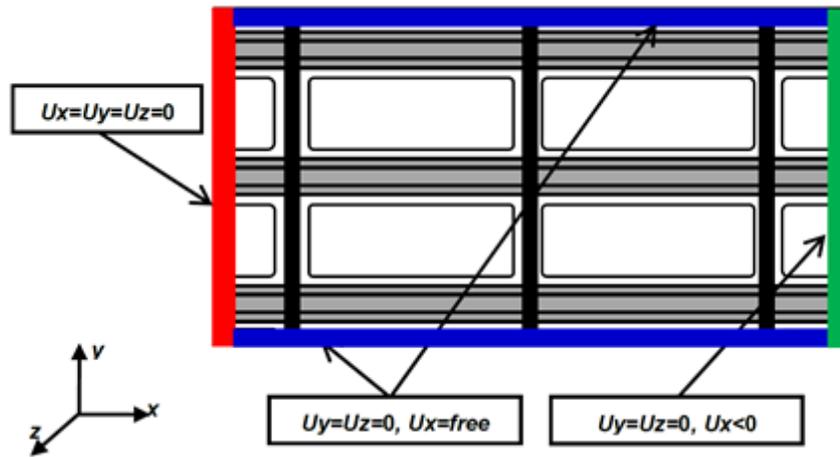
Before testing, the panels were subjected to the necessary preparation to ensure correct application of loading. To uniformly apply the boundary conditions and load and to avoid any local damage in the skin and stringers at the loaded edges, two potting frames were adjusted at the both sides of the panel. Schematic of the boundary conditions applied during the mechanical testing is shown in Fig. 3. The potting frames were made from epoxy resin which was cured inside a metallic block. Before testing, measurements were taken on the verticality of the sides of the potting frame. It was found that the two planes of the frame are not completely

vertical and the upper plane of the frame is not completely vertical to the panel and, thus, to the loading plane of the grip. This deviation possibly caused load eccentricity phenomena which should be taken into account at the evaluation of the experimental results.

Fig. 3: Schematic of the boundary conditions applied in the model.

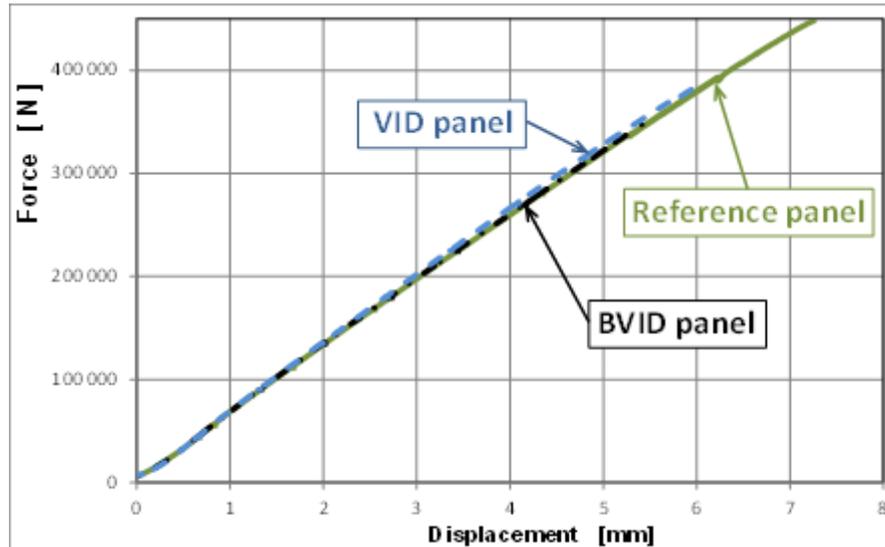
Fig. 4 compares the recorded load-displacement curves of the three panels loaded in compression. In all three tests, a linear relation between the applied displacement and load up to final failure was recorded. Reference panel failed at 448 kN achieved at 7.28 mm displacement. BVID panel failed at 350 kN achieved at 5.43 mm and VID panel failed at 381 kN achieved at 5.95 mm displacement. Fracture modes were very similar for all the panels. An important observation about the fracture of BVID and VID panels was that fracture of the skin and stringers seems to be related with impact damages and artificial delamination. The failure load and displacement to failure of VID panel were decreased by 15 % and 12.12 %, respectively, due to the presence of VID sites. The application of several BVID caused non-visible delamination, which either acted independently or interacted with initial artificial delamination to degrade significantly the compressive strength of BVID panel.

Fig. 4: Comparison of force vs. displacement curve of tested panels.

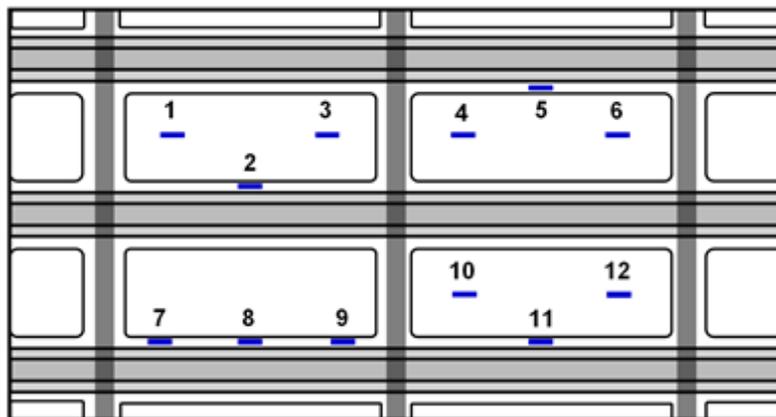
The accuracy of the measurements taken from FOBGs with SGs as well as their correlation with the failure sequence in the panels are crucial for the effectiveness of the proposed sensors system. The topology of the FOBG network in the panels is shown in Fig. 5. This figure documents all FOBG lines (three sensors (S) per

line) in the panels. Only three lines (L) were applied to the individual panels. The lines and sensors positioning on/into the individual panels is defined in Tab. 1.

Fig. 5: Topology of sensors placed in the panels.

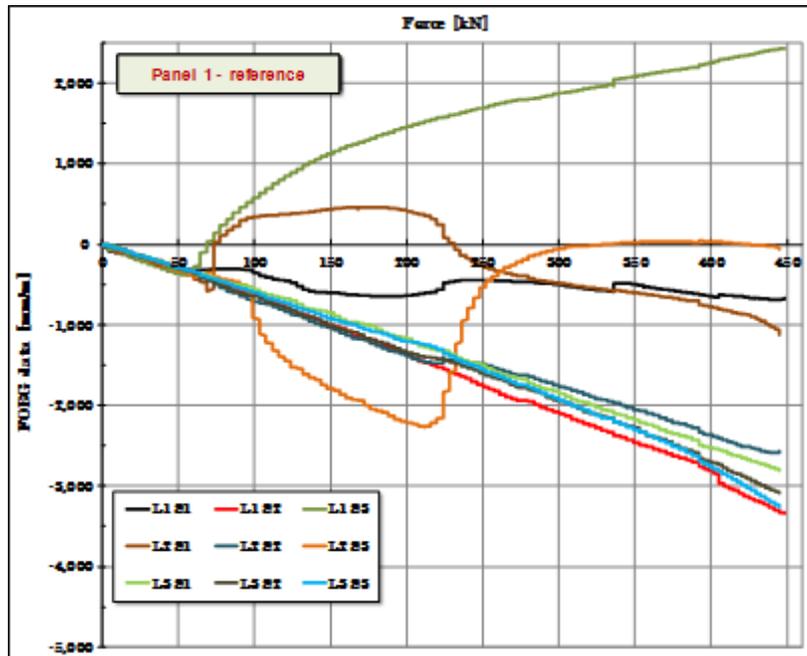
Fig. 6 illustrates the strain vs loading force dependences measured by the FOBGs during test of reference panel. The first local buckling occurred at skin bays at around 65 kN (14.5 % of the failure load). This local buckling was detected by L1S3 and L1S1 sensors, which are placed at the skin bay. Next buckling initiated also at the other skin bays under a little bit higher load levels as indicated by the change in the measurements of L2S1 and L2S3. The next events that indicated the changes in the buckling mode of the skin occurred at 225 kN (captured by L2S1, L2S3, L1S1, L3S2 and L2S2), at 335 kN (captured by L1S1 and L1S3), 390 kN (captured by L2S1, L3S1, L3S2 and L3S3) and 405 kN (captured by L1S2). The data measured using L2S2, L3S1, L3S2, L3S3 and L1S2 sensors are constantly compressive varying almost linearly with applied load. All these sensors are placed on the stringers. No major changes in the deformation took place in the areas around

the stringers. On the contrary, the large variation in the measurements of L1S3, L2S1, L1S1 and L2S3 sensors located in skin bays areas indicates large variation in the deformation. The plots measured for other panels show very similar behaviour.

Fig. 6: FOBG strain history during static test of the reference panel.

In general, the FOBGs captured all events in the three panels which are mainly related to the change in the buckling mode of the skin. The measurements from FOBGs placed in the bay areas can be translated into useful information regarding the structural health of the panel. Regarding final failure, the FOBG measurements did not give a clear warning possibly due to the fact that final failure occurs suddenly. However, if strain to failure is known, then the strain values of the FOBGs can be the warning themselves and also give information about residual strength of the panel.

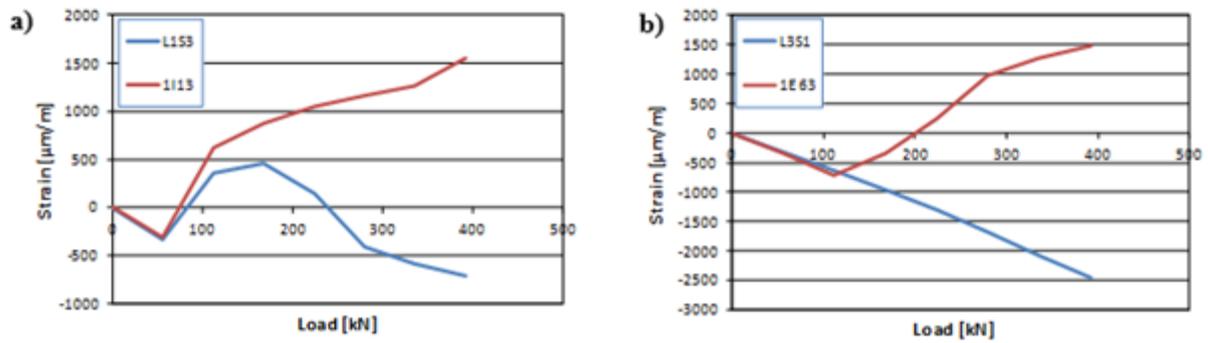
To validate strain measurements of FOBGs, the strain measurements of SGs were used. The locations of some SGs were selected to coincide with FOBGs. Fig. 7 shows comparison of the strain data of FOBGs L1S3 and L3S1 with the SGs 1113, and 1163, respectively, for reference panel. Until the first buckling in the panel structure (force lower than 65 kN), a perfect agreement between L1S3 and 1113 was achieved. For this case, the accuracy of the measurement taken by the FOBG was validated. At 65 kN, local buckling initiated at the bay where strain was measured. The measurements from the FOBG and the SG were quite similar up to 115 kN load. After that load, they deviated significantly due to the alteration of the buckling modes, which occurred in the location of the two sensors positioned in opposite panel sides. Regarding the measurements taken from L3S1 and 1E63, they coincided up to 115 kN. After that point, they started to deviate. The measurement of FOBG L3S1 seems to be not affected by the buckling while the measurement taken from 1E63 changed from negative to opposite due to buckling. The same correlation between FOBGs and SGs was observed for other panels.

Fig. 7: FOBG strain history during static test of the reference panel.

In general, the comparison between FOBGs and SGs validates the accuracy of the measurements taken from FOBGs. No significant differences were found. In all cases, prior to buckling occurring, the measured strains between the sensors coincided. When buckling was started, the measurements of some sensors started to deviate mainly due to the different buckling curvature of the measurement locations. Differences were mainly observed in the case of sensors which were placed on/in the skin in areas where buckling curvature is significant. This is probably due to combination of the following facts: the SGs were placed on the surface of the skin contrary to FOBG sensors which are placed on the opposite side of the skin or were embedded into the composite structure; the significant buckling amplitude invokes the occurrence of bending loads which can result to tension strain

on one skin surface and compression strain on the opposite skin surface. The above statements are verified by the fact that the agreement between FOBG and SGs data is very good for the entire loading procedure in case of sensors placed on the stringers which did not buckle.
